**Underwater Inspection &
Assessment of Piles & Floats
Fidalgo Marina
Anacortes, WA**

June 2021
21-2604

**RE: Underwater Inspection & Assessment of Piles & Floats
Fidalgo Marina, Anacortes, Washington**

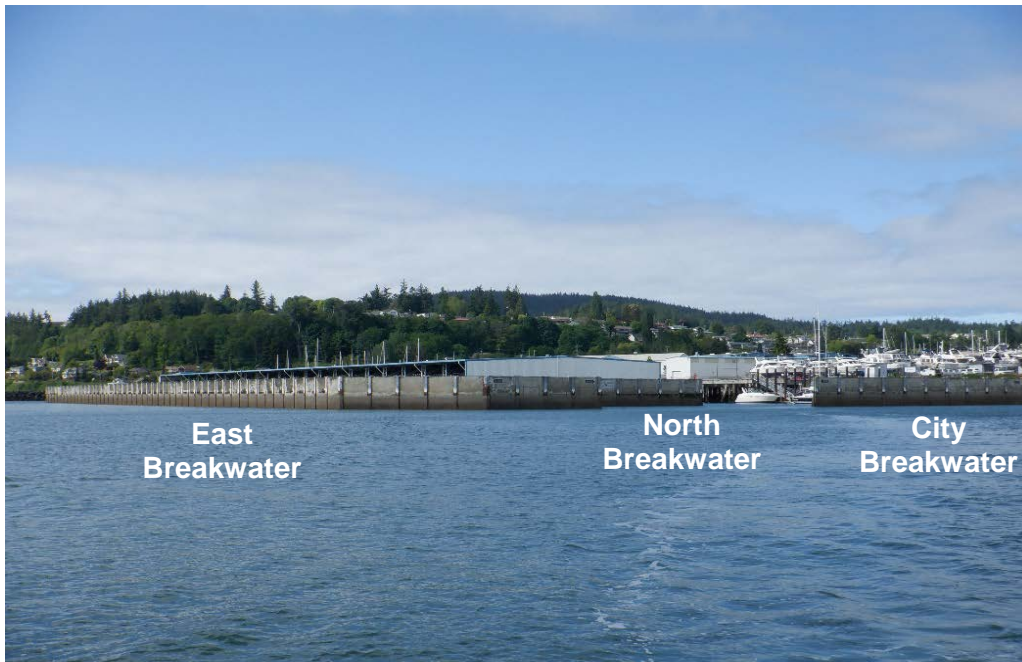
PHOTO No. 1: Fidalgo Marina, Looking Southwest - The marina moorage consists primarily of covered slips constructed with concrete floats that are secured in place by prestressed concrete piles. The marina is protected by a steel pile supported concrete panel breakwater.

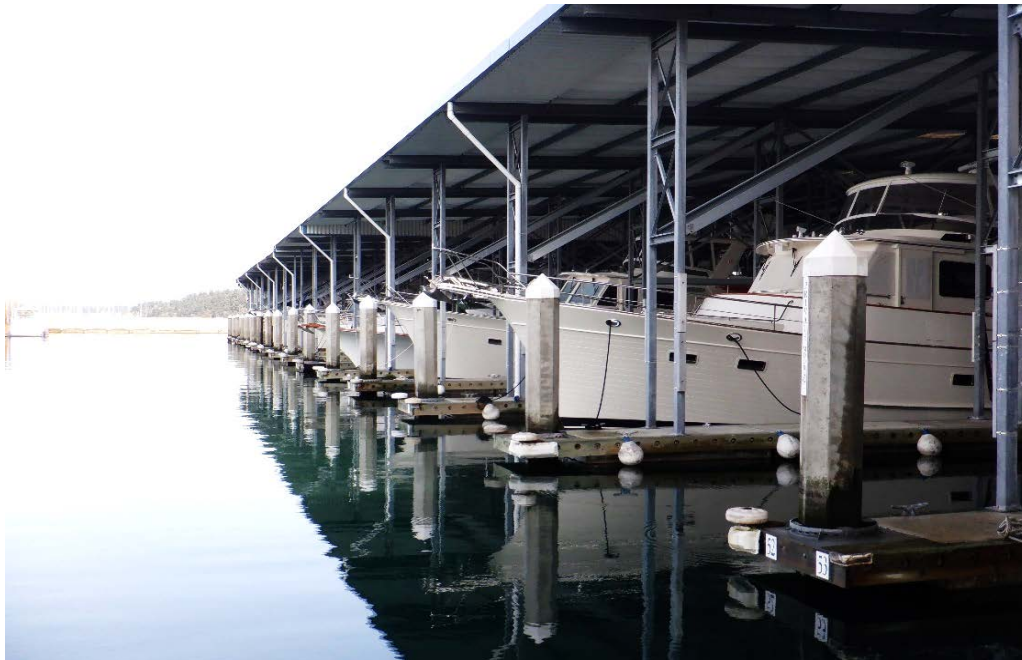
PHOTO No. 2: Marina Moorages, West Edge, Looking North - Note the overall good condition of the prestressed concrete float anchor piles, as well as the steel column and roof support system which bears directly on the floats.

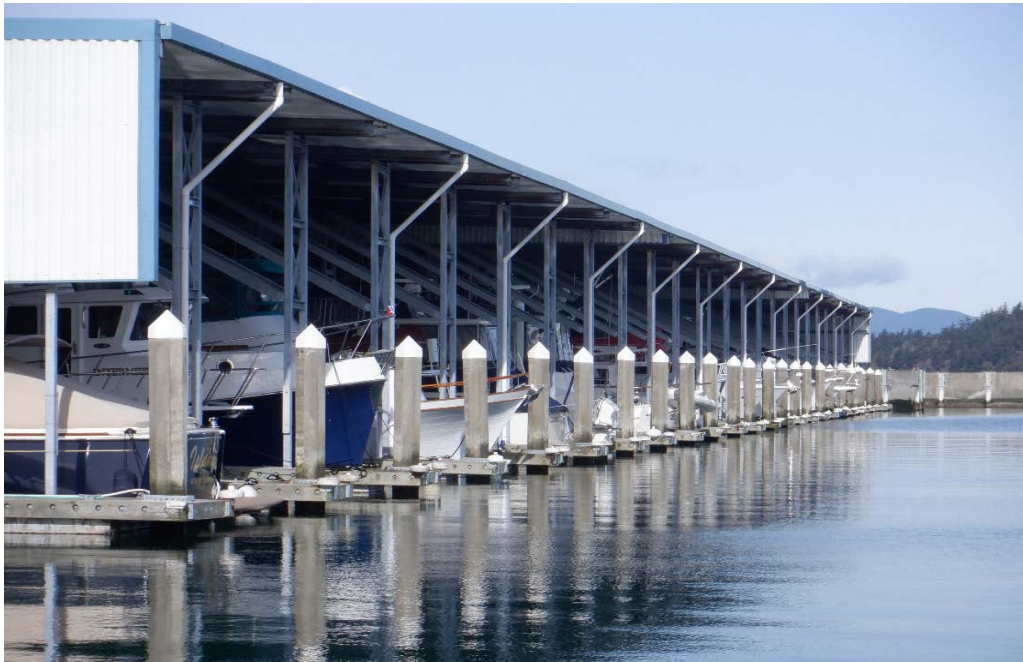
PHOTO No. 3: Marina Moorages, West Edge, Looking North - Note the good condition of the concrete piles and floats in this area. Also note the north end of the East Breakwater visible in the background.

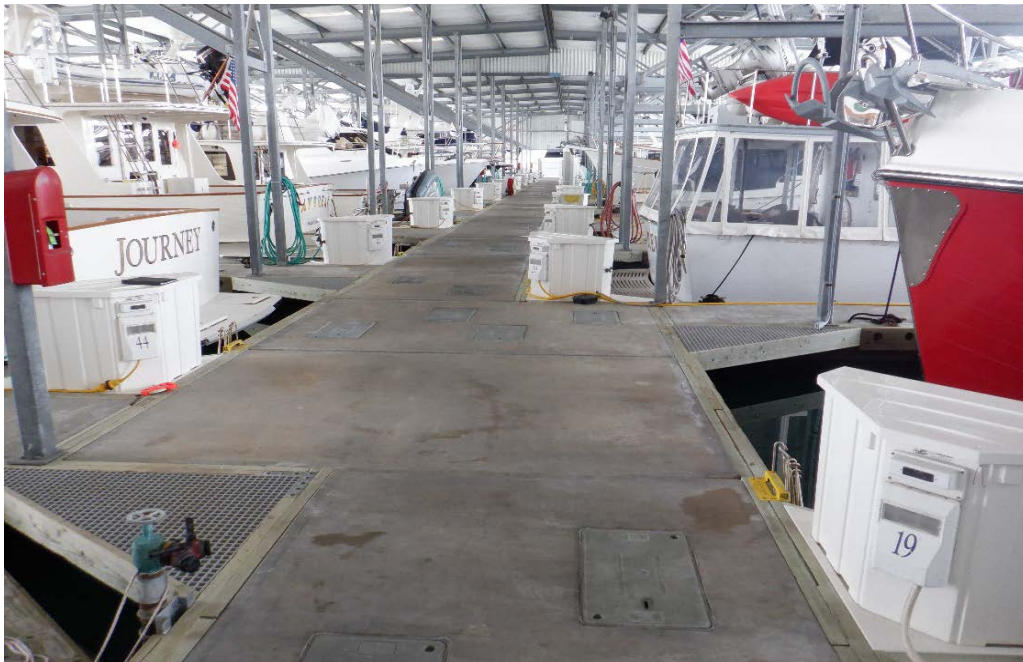
4. cursory observation noted that the pontoons are floating level with good freeboard. No evidence of supplemental floatation was observed under any of the sampled floats. Refer to Photos No. 4 and 5.
5. The timber wales securing the individual pontoons that make up both the central walkway, as well as the individual finger floats were noted to be in good condition with no significant damage to the timbers or to the bolted connections observed. Refer to Photo No. 4.
6. Visual inspection of the restraint hoops that secure the floats to float anchor piles found them to be in good condition. No evidence of significant corrosive section loss was noted on any of the sampled members. The HDPE rub strips located within the hoops were also noted to be in generally good condition. Refer to Photo No. 6.

PHOTO No. 4: Marina Float, Main Access, Looking North - Note the overall good condition of the concrete pontoons which are floating level and with good freeboard. Also note the overall good condition of the timber wales securing the individual pontoons together.

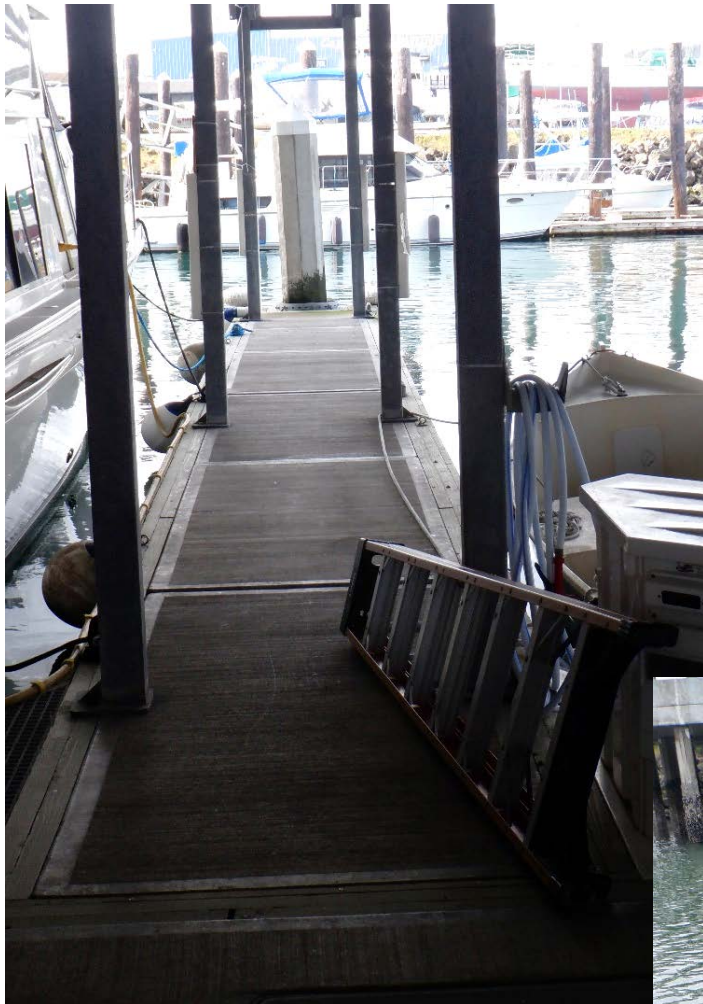
PHOTO No. 5: Float Anchor Pile No. 54, Looking West - Note the overall good condition of the prestressed pile and the individual concrete pontoons which make up the floats. Also note the pontoons are level with good freeboard.

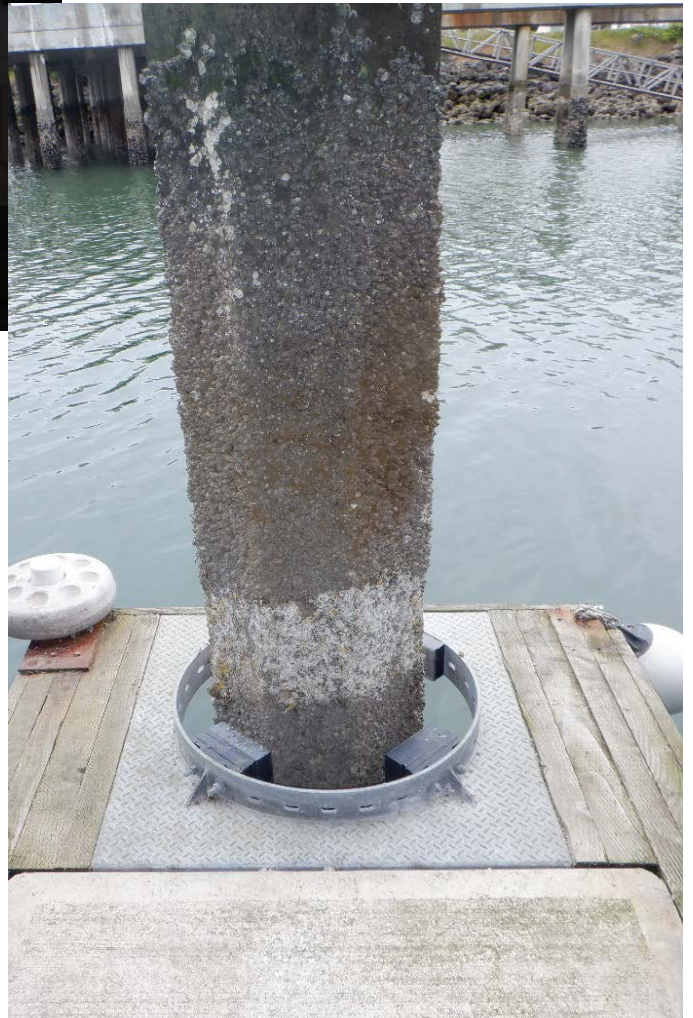
PHOTO No. 6: Float Anchor Pile No. 48, Looking West - Note the area of Level II cleaning visible in the intertidal zone just above the deck. Level II cleaning and detailed inspection was performed on a sampling of the concrete float anchor piles throughout the marina. Also note the typical good condition of the pile hoop and the HDPE rub strips.

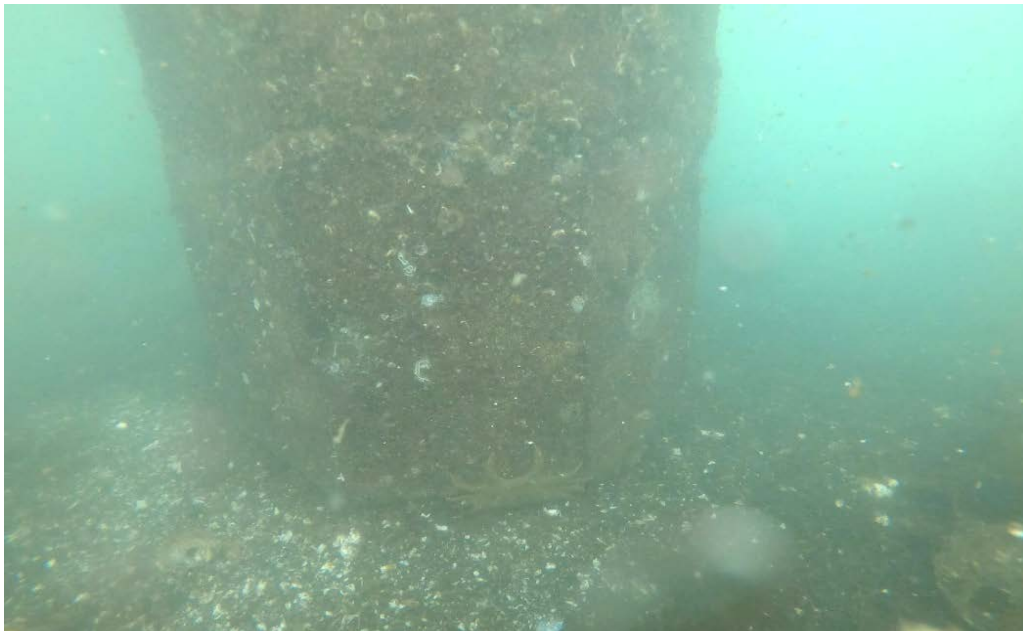
PHOTO No. 7: Float Anchor Pile No. 10 - Note the overall good condition of the concrete pile with well defined corners and no evidence of any cracking, spalling or rust bleeding. Also note the silty-sand and gravel composition of the mudline. Both of these conditions were found to be typical of the float anchor piles throughout the marina.

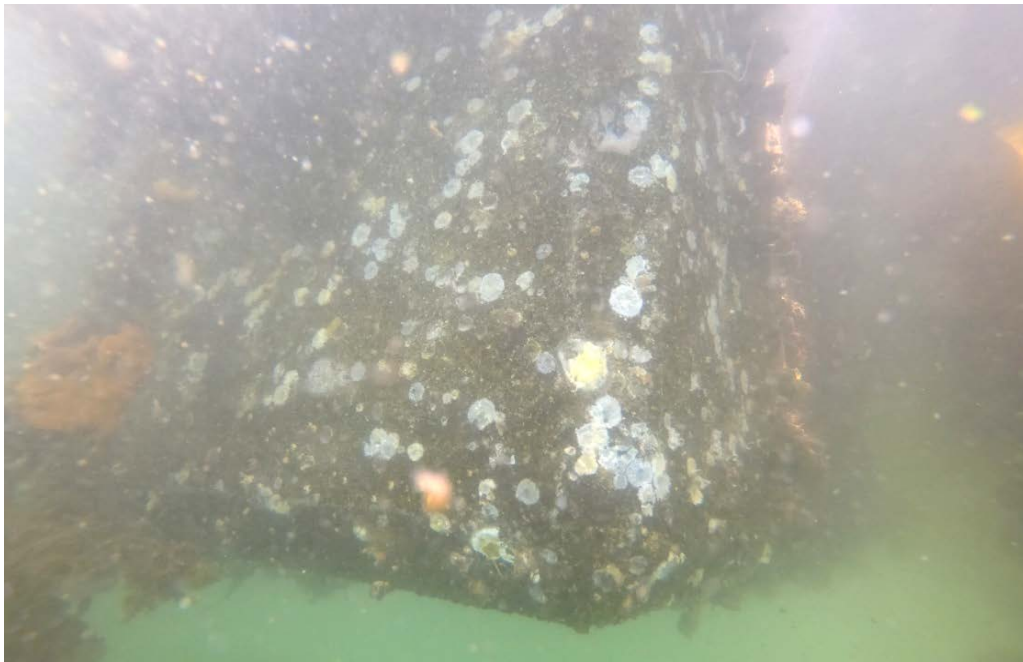
1. Refer to Appendix C, Table 1 for Level I inspection results.
2. The float anchor piles were found to be in overall good condition. Of the 16 piles selected for Level I and II inspection, all were found to be undamaged. No evidence of any visible cracking, spalling, rust bleeding or other defect was noted on any of the inspected members. Refer to Photos No. 2, 3, 5, 6 and 7.
3. Inspection of the concrete floats found the overall condition to be generally good. The floats that make up the covered moorage areas, as well as the floats that are located in the open marina slips were all noted to be in good condition. No evidence of significant cracking, spalling, rust bleeding or other defects were noted on any of the inspected members. Refer to Photo No 8.

PHOTO No. 8: Concrete Float, Near Pile No. 10 - Note the well defined corners of the concrete pontoon, with no evidence of any cracking, spalling, or rust bleeding visible. No supplemental floatation was noted during our inspection, and the sampling of inspected floats were found to be floating level with good freeboard.

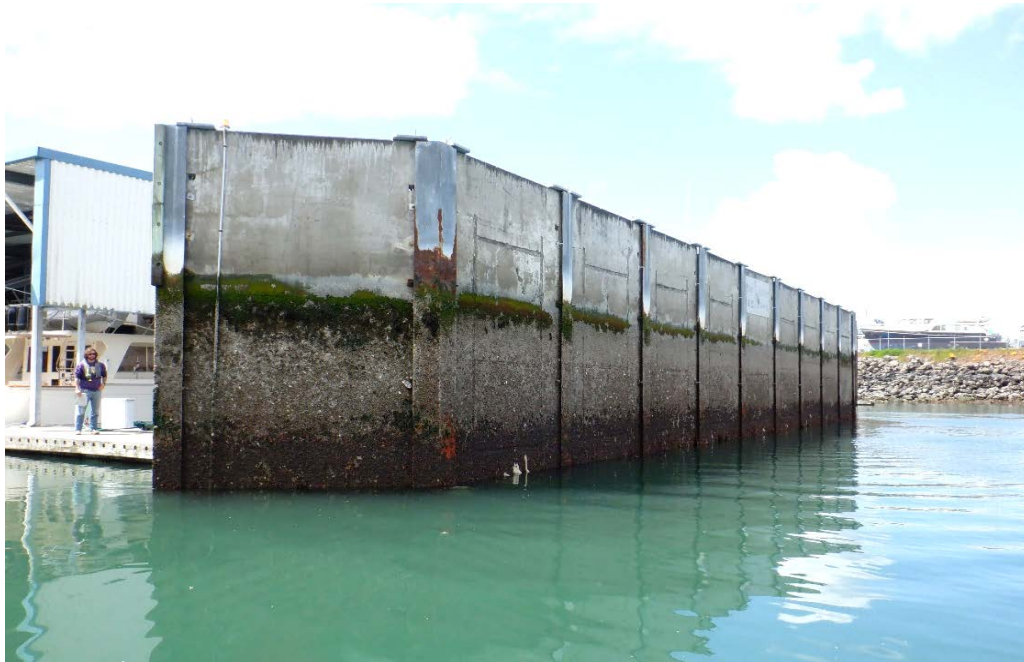
5. Inspection of the concrete wave break panels found them to be in fair to good condition. Although minor cracking was evident above water, no evidence of any significant deterioration or damage was found. The galvanized hardware securing the panels to the H-piles was noted to range in condition from fair to good. Typically, the hardware at the top of the breakwater and in the splash zone was in good condition with minimal loss of galvanized coating. Hardware located in the intertidal, submerged and mudline zones was found to range from fair to good with deterioration of the protective coating and an estimated 5-15% loss of section noted on several of the members. Refer to Photo No. 9.

PHOTO No. 9: North Breakwater, Looking West - This is one of two smaller breakwaters that protect the entrance to the marina. Both are constructed with 11 sets of vertical steel H-piles with a steel pipe pile batter, with inset concrete panels extending from the top of the breakwater to the mudline.

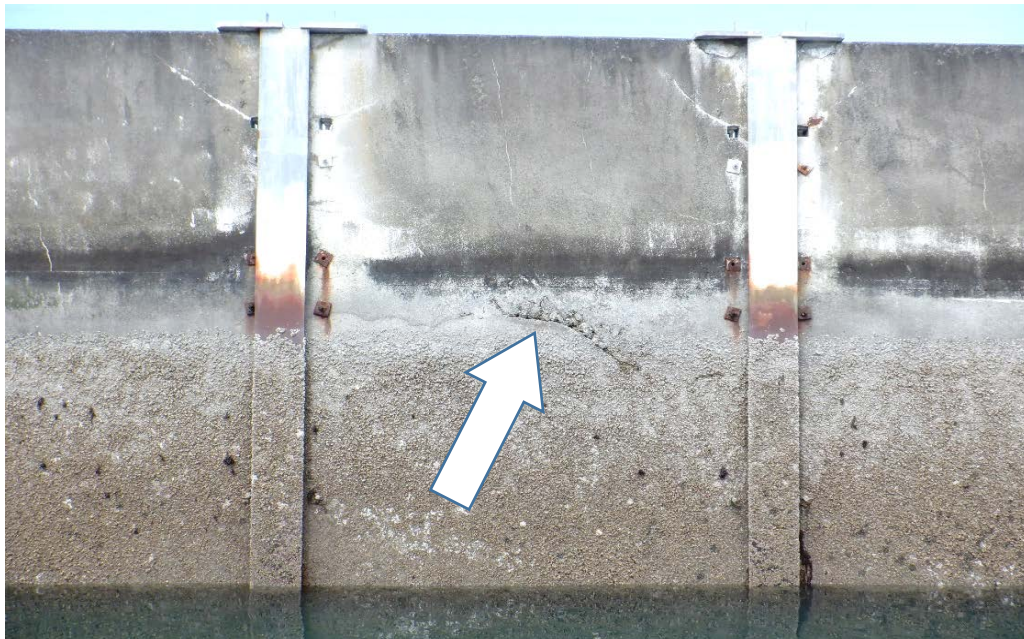
5. Inspection of the concrete wave break panels found to be in fair to good condition. Although minor cracking was evident above water, no evidence of any significant deterioration or damage was found. One panel located between Piles No. 24 and 25 was noted to have a repair patch likely dating back to the time of original construction. No evidence of deterioration or damage was associated with this anomaly. Refer to Photo No. 10.

PHOTO No. 10: East Breakwater, Exterior Face, Piles No. 24 and No. 25 - Inspection noted this apparent form void in the center of the concrete panel. Close examination found that the area has been repaired in the past with grout. Partial dis-bondment of the grout was evident, however no exposed reinforcing or rust bleeding was noted.

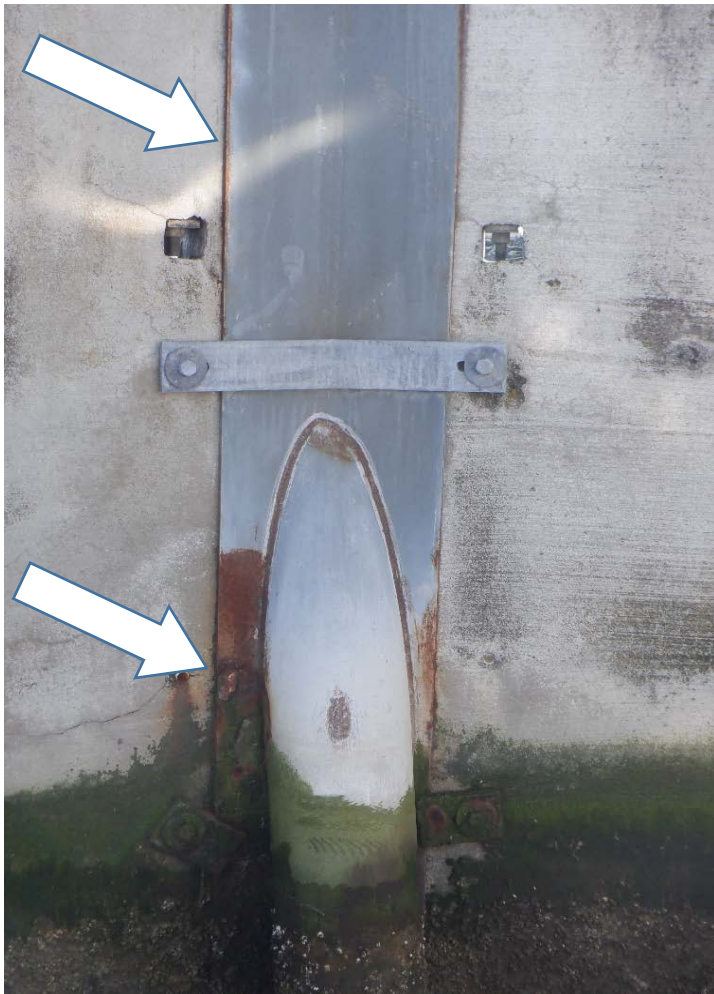
PHOTO No. 11: East Breakwater, Interior Face, Pile No. 72 - Note the generally good condition of the galvanized steel above high tide. The galvanized protective coating was found to be primarily intact on the upper portions of the piles. However, deterioration of the coating was evident on the H-Pile flange ends (refer to upper arrow), on the welds, and on the piles in the lower splash and upper intertidal zone (refer to lower arrow).

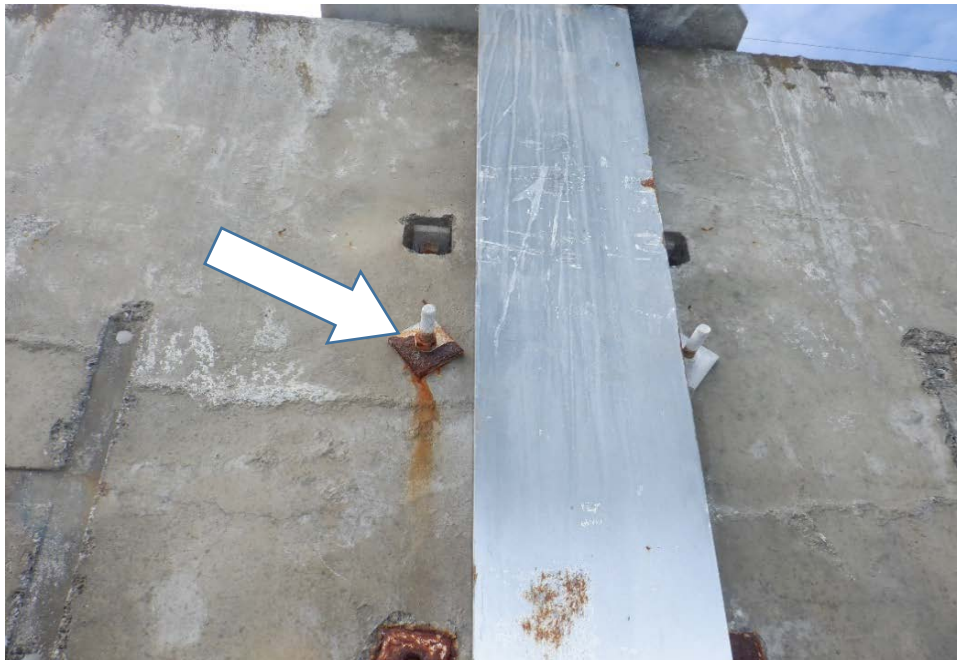
The galvanized hardware securing the panels to the H-piles was noted to range in condition from fair to good. Typically, the hardware at the top of the breakwater and in the splash zone was in good condition with minimal loss of galvanized coating. Hardware located in the intertidal, submerged and mudline zones was found to range from fair to good with deterioration of the protective coating and an estimated 5-15% loss of section noted on several of the members. Refer to Photos No. 12, 15 and 16.

PHOTO No. 12: Breakwater, Exterior Face, Typical Condition - Note the corrosion evident on the connection hardware which secures the concrete panel (refer to arrow). Also note the overall good condition of the protective coating on the H-Pile in the splash zone.

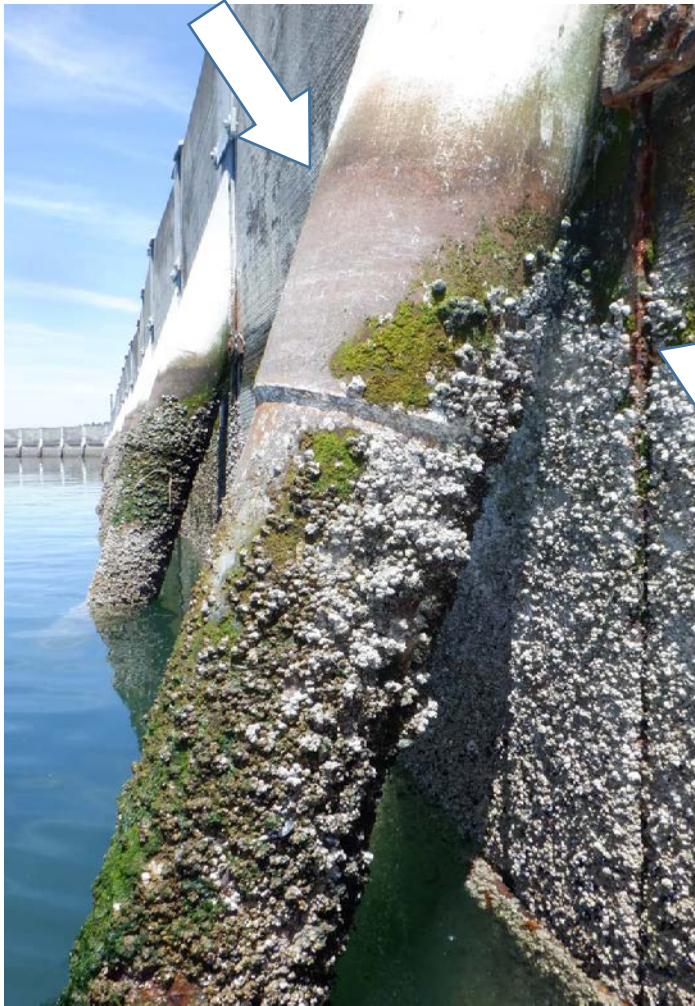
of 0.615 inches. The original thicknesses of the flanges were obtained by taking thickness measurements in the splash zone in areas of undamaged coating. Although no evidence of perforation of the pile flanges on either the interior or exterior faces of the breakwater was found, the majority of the piles exhibit bright orange active corrosion and visible section loss of the flange ends from the intertidal zone to the mudline. Refer to Photos No. 13, 14 and 19

PHOTO No. 13: East Breakwater, Looking North - Note the overall good condition of the protective coating on the piles above the high water mark (background). Also note the deterioration of the coating and corrosion of the base metal on both the pipe pile sleeve and on the H-pile flange edge in the intertidal zone. (refer to arrows).

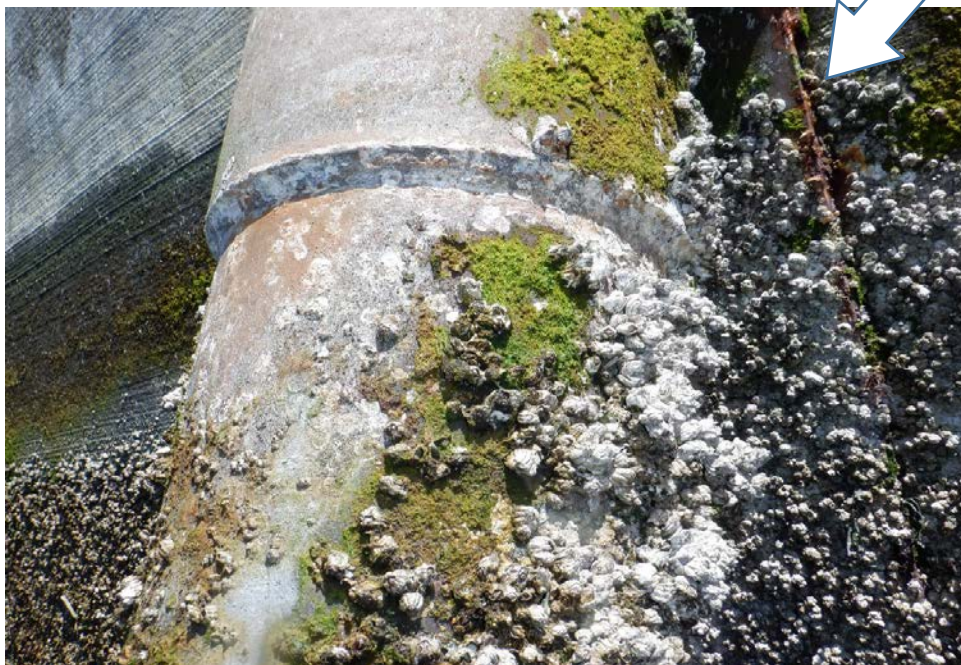
PHOTO No. 14: East Breakwater, Sleeve / Socket Weld - Level II cleaning of the Pipe Sleeve to Pipe Pile socket connection found the welds to be in overall good condition. Also note the corrosion of the H-pile flange (refer to arrow) and the overall good condition of the concrete panel on the left.

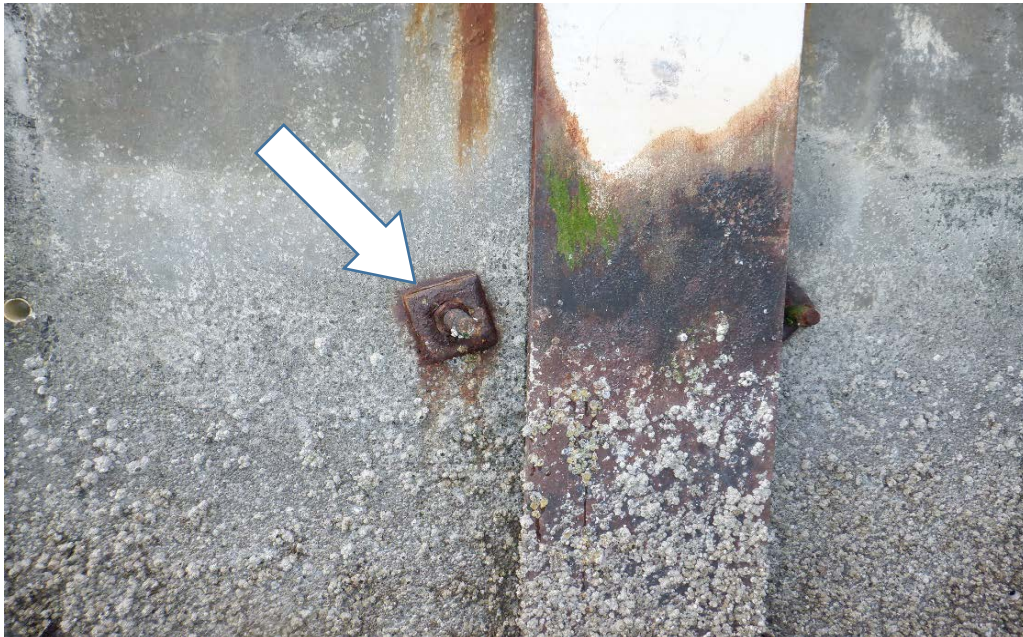
PHOTO No. 15: Breakwater, Exterior Face, Typical Condition - Note the moderate to heavy corrosion and scale of the attachment hardware which serves to secure the concrete panels to the H-Piles (refer to arrow). Also note the failed coating and corrosion of the pile from the high tide down and the overall good condition of the coating above. This was found to be typical of the piles throughout both breakwaters.

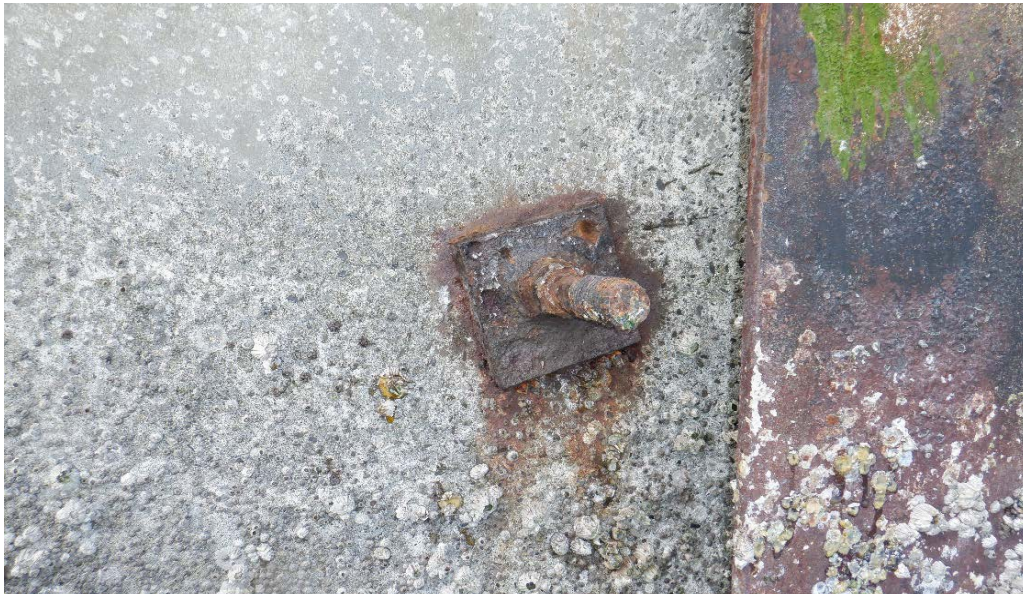
PHOTO No. 16: Breakwater, Exterior Face, Typical Condition - Close up of connection bolt, plate washer and nut shown in Photo No.15 above. Note the moderate to heavy corrosive section loss visible on the hardware. This condition was found to be typical of many of the bolted connections located in the intertidal and submerged zones.

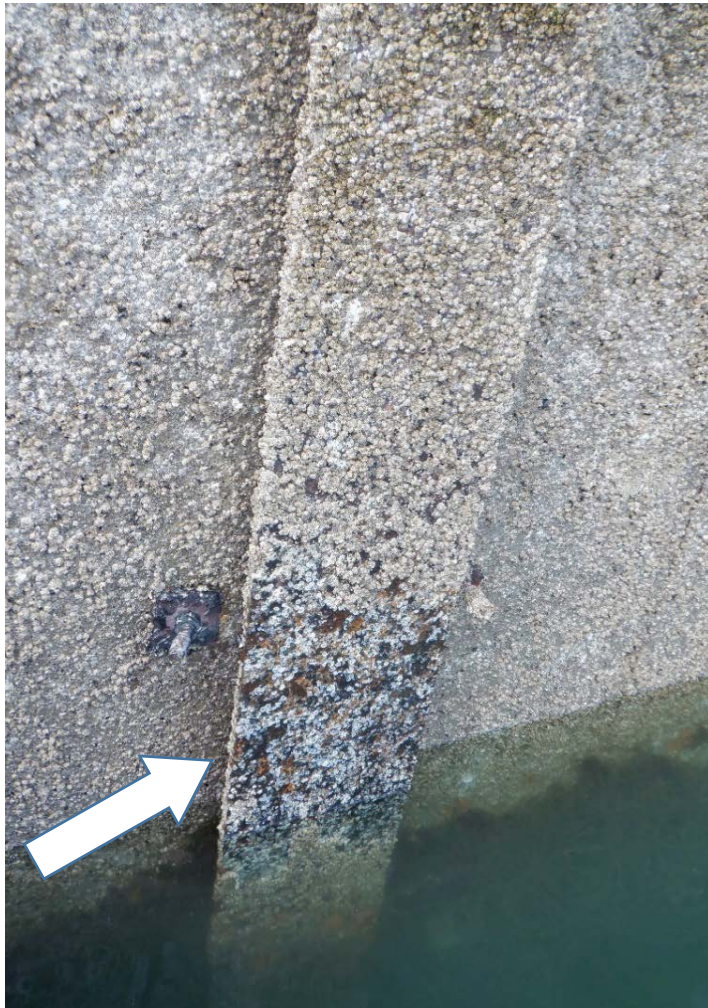
PHOTO No. 17: North Breakwater, Exterior Face, Pile No. 2 - Note the Level II cleaned area on the steel H-Pile at the water surface showing localized failure of the galvanized coating. Also note the gap between the concrete panels and the flanges of the H-Pile (refer to arrow). The concrete panels are flush with the H-Pile flanges on the inside face of the breakwater.

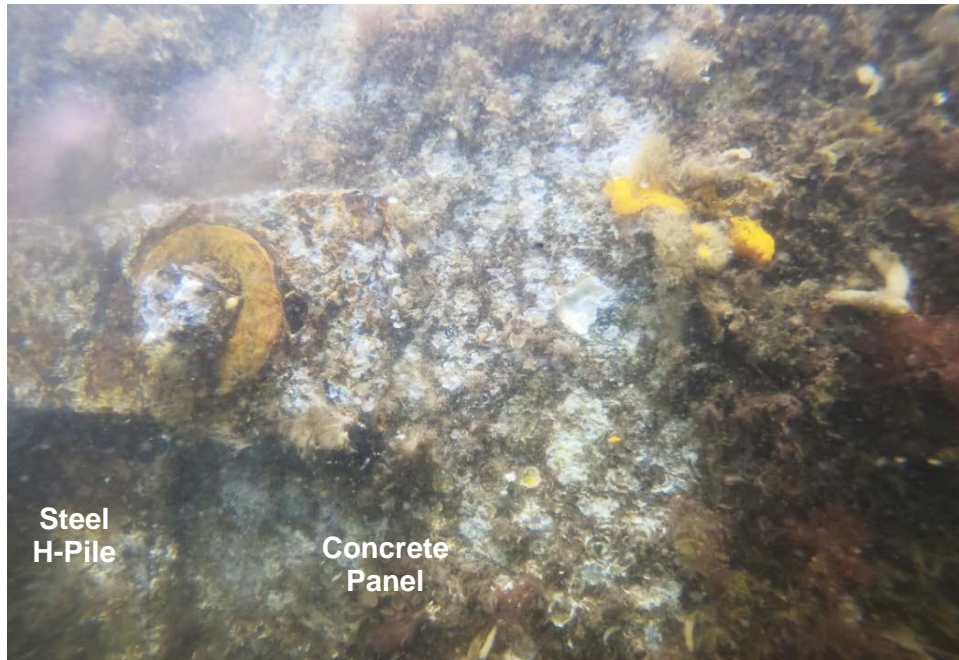
PHOTO No. 18: North Breakwater, Interior Face, Concrete Panel Connection Plate - Note the Level II cleaning of the concrete panel and the steel plate connection bracket. The concrete was found to be in overall good condition, while moderate surface corrosion is visible on the steel plate and hardware.

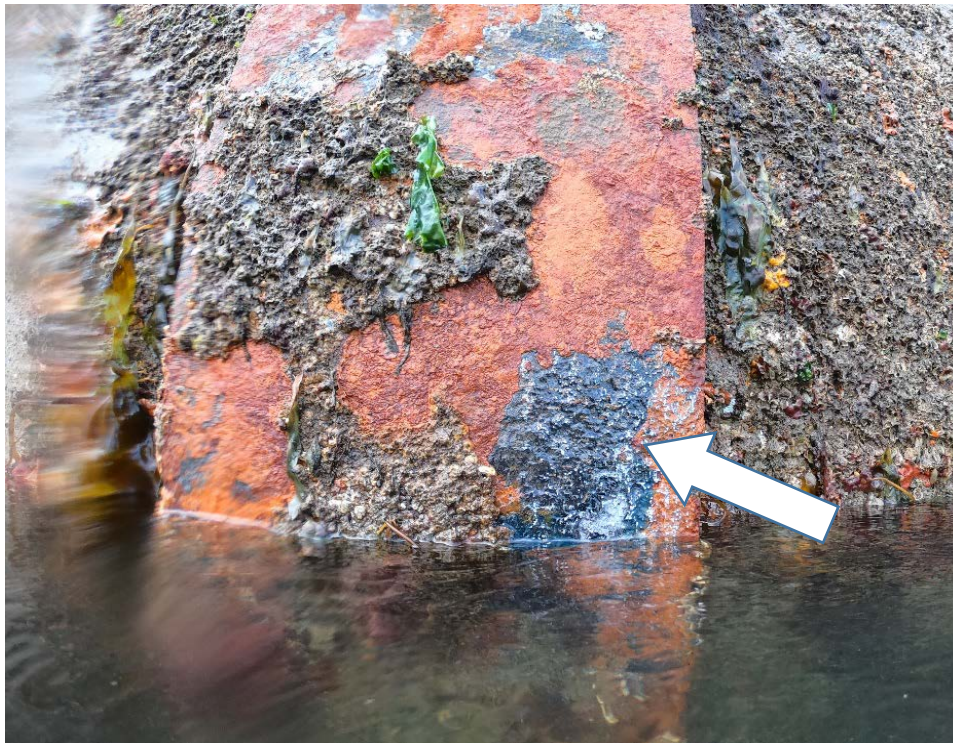
PHOTO No. 19:

3. The overall condition of the vertical H piles was found to be fair. Based on the design drawings these piles are HP 14 x 89 members with nominal flange and web thicknesses of 0.615 inches. The original thicknesses of the flanges were obtained by taking thickness measurements in the splash zone in areas of undamaged coating. Although no evidence of perforation of the pile flanges on either the interior or exterior faces of the breakwater was found, the majority of the piles exhibit bright orange active corrosion and visible section loss of the flange ends from the intertidal zone to the mudline. Refer to Photo No. 19.

Breakwater, Exterior Face, Typical H-Pile - Note the large area of active corrosion evidenced by the bright orange coloration. A localized area has been subjected to Level II cleaning (refer to arrow). Pit depth measurements in this area indicate an average depth of ~1/8 inch. This is typical of many of the piles in the lower intertidal, submerged and mudline zones.

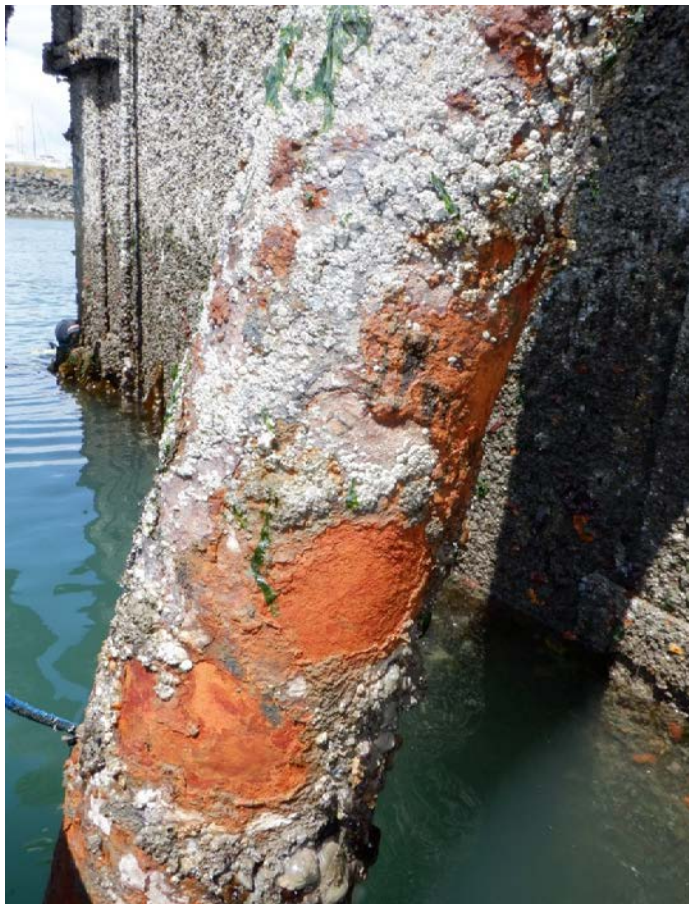
Level III ultrasonic thickness readings taken on eight representative pipe piles in the breakwater found the remaining thicknesses to range from 0.180 inches to 0.390 inches with an average thickness of 0.305 inches (~18.8% loss). The most significant losses were measured throughout the submerged length of the piles. Refer to Photos No. 20 – 22.

PHOTO No. 20: East Breakwater, Pipe Pile No. 2 Br - Note the bright orange, active corrosion and heavy scale visible on the pile in the lower intertidal zone. This level of active corrosion was found to be typical of the majority of the batter piles within both the North and East Breakwaters.

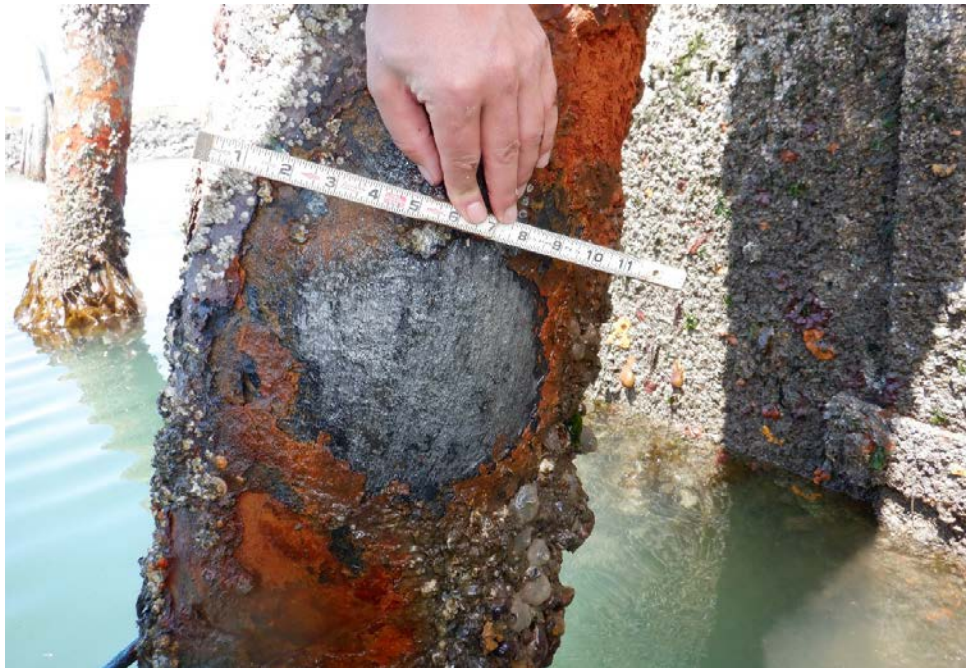
PHOTO No. 21:
East Breakwater,
Pipe Pile No. 2 Br -
Note the bright
orange, active
corrosion and heavy
scale visible on the
pile in the lower
intertidal zone. Level
II cleaning and
detailed inspection
noted that the base
metal is rough with
areas of localized
pitting.

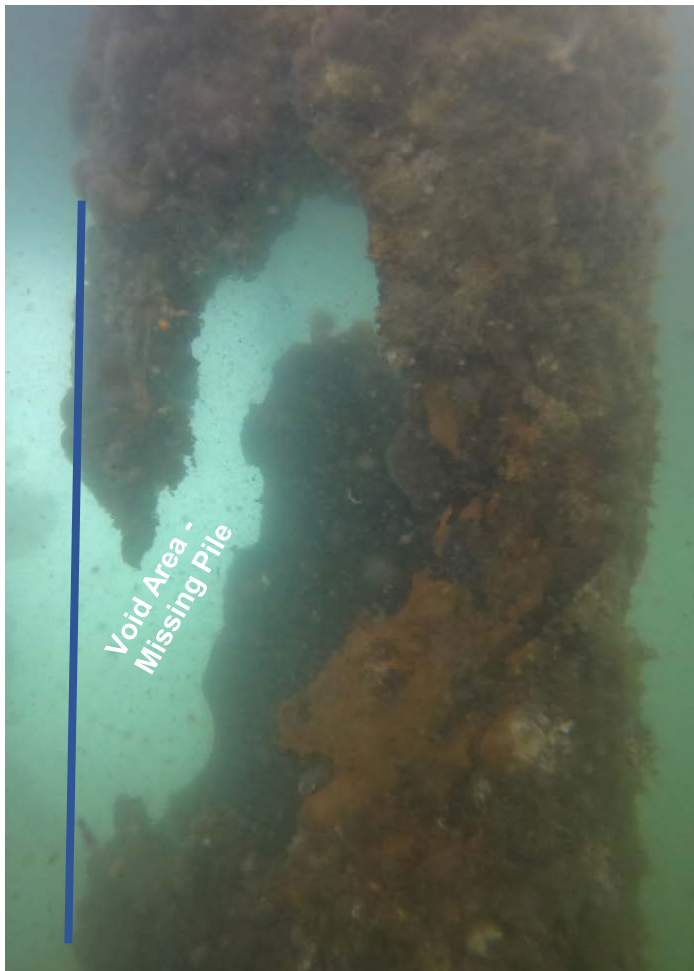
Level III ultrasonic thickness readings taken on a representative pipe pile in the breakwater were found to range from 0.130 inches to 0.200 inches with an average thickness of 0.165 inches (~56.0% loss). The most significant measured loss was obtained in the intertidal zone on Pile No. 2 Br, resulting in ~65.3% loss. It should be noted that this pile has ultimately failed with >60% of the section lost in the submerged zone. Refer to Photo No. 22.

PHOTO No. 22: North Breakwater, Pipe
Pile No. 2 Br - Inspection
found extensive
corrosion, perforation and
loss of section on this
batter pile. Note the blue
line indicating the location
of the original pipe pile
wall which is now
missing. Inspection
found nine of the eleven
batter piles in the North
Breakwater and ten of the
79 batter piles in the East
Breakwater to have
sustained corrosion to the
point of perforation.
