# Fidalgo Marina Breakwater Repair Options

Prepared for:  
Fidalgo Marina Owner's Association  
3101 V Place  
Anacortes, Washington 98221  
Phone: 360-293-7033

Prepared by:  
PND Engineers Inc.  
1736 Fourth Avenue South,  
Seattle, Washington 98134

# **FIDALGO MARINA BREAKWATER REPAIR OPTIONS**

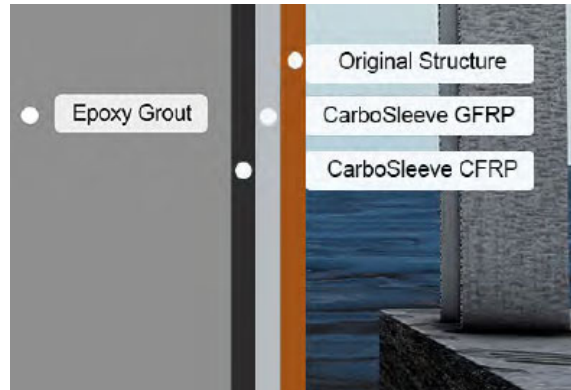
PND investigated multiple off-the-shelf pile repair options for the breakwater vertical and batter piles. CarboShield Inc. utilizes carbon fiber technologies and grout to provide repair solutions for piles. For the batter piles, the CarboSleeve product would be utilized to repair the piles and provide strength in excess of the original piles. The CarboSleeve repair involves placing a carbon fiber and glass fiber sleeve inside of the pipe pile. These sleeves are pumped full of grout, effectively creating a new pile inside of the existing steel pile. The figure below shows what the section of the repaired pile would look like.

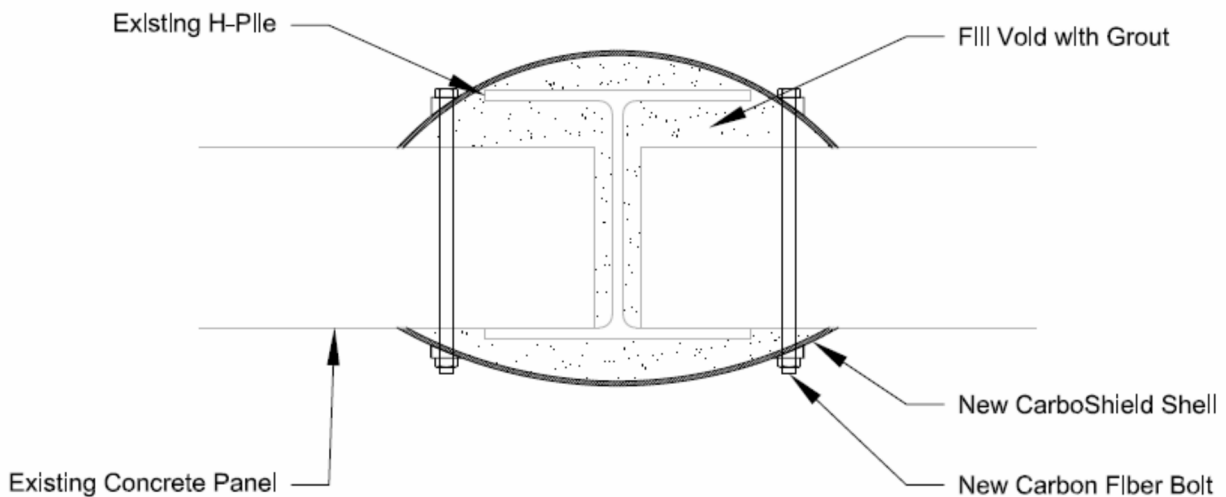
The vertical piles would be repaired utilizing the CarboShield technology. This would entail two semi-circular carbon sleeves on each side of the h-pile (similar to the sketch below). The carbon sleeves would be bolted together through the existing concrete panels. The void inside of the carbon sleeve is filled with grout. This repair would not add strength to the existing pile but would serve to stop any further corrosion of the piles. All elements of both pile repairs are non-corrosive.

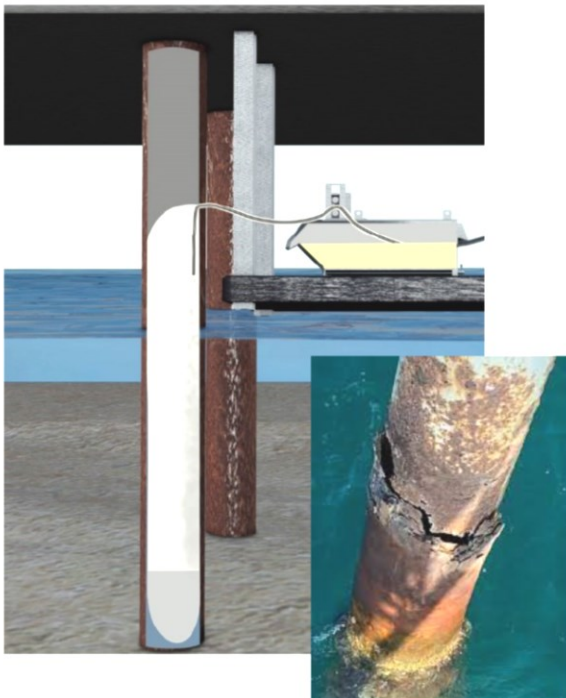
Figure 1 Figure depicts repair using CarboSleeve.

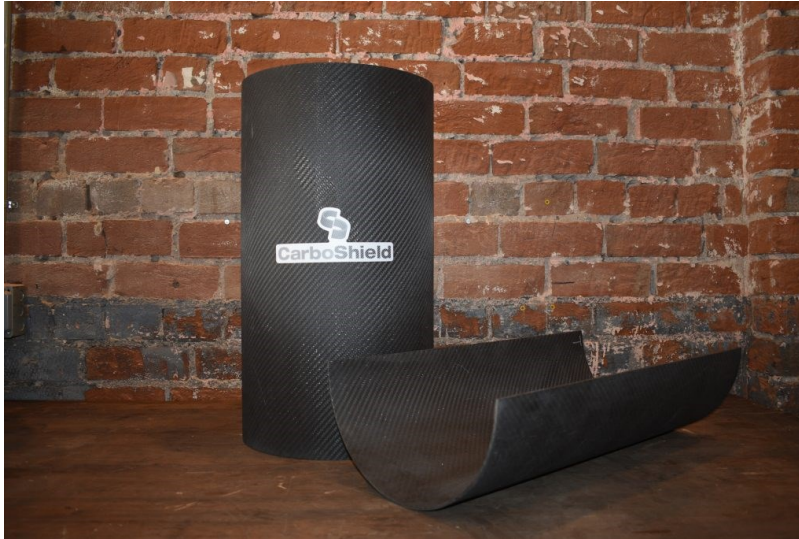
Figure 2 CarboShield product proposed for vertical H piles connecting the wave panels.

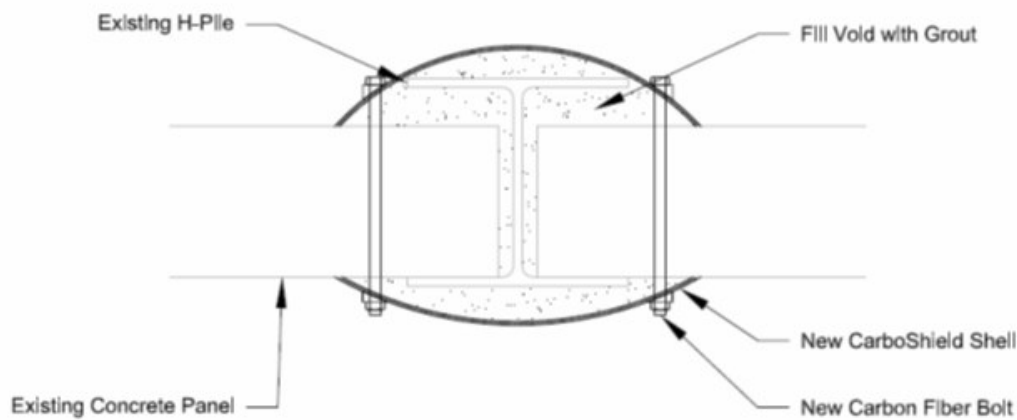
Figure 3 H pile showing proposed repair of vertical H piles with CarboShield.
