March 25, 2023

Mr. Samuel Hill  
Fidalgo Marine Owners Association  
3101 V Place  
Anacortes, WA 98221

**SUBJECT: Fidalgo Marina Breakwater - Post Cathodic Protection Installation Checkout**

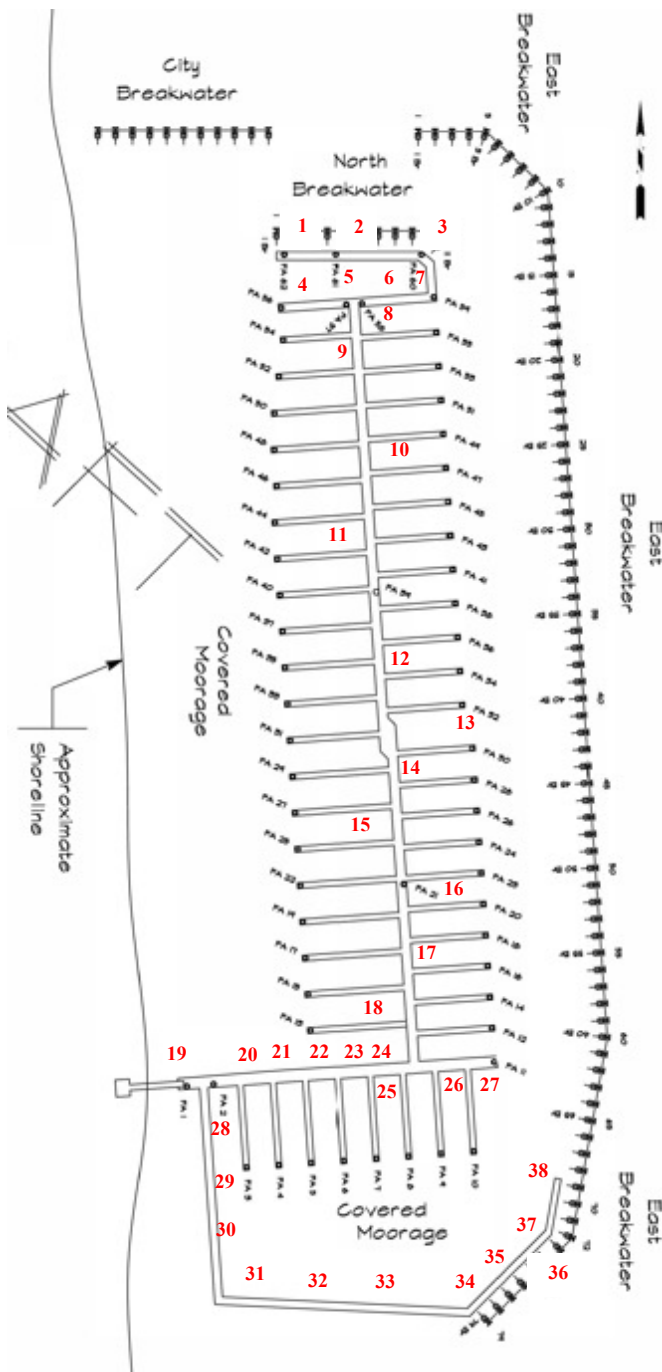
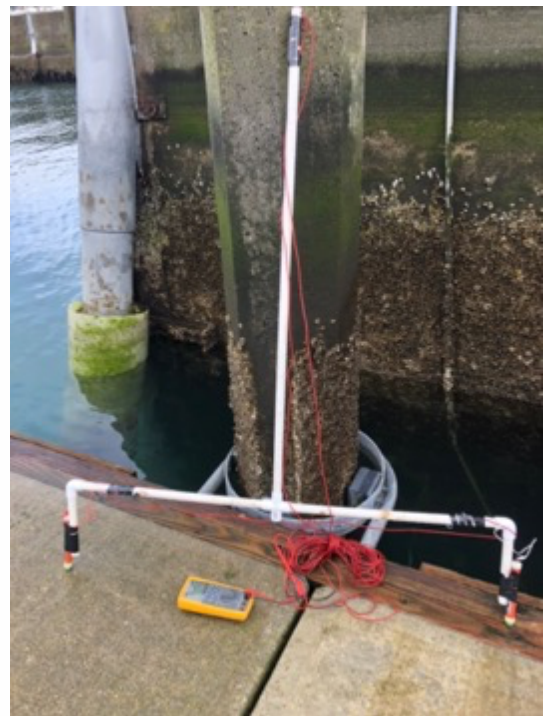
**Figure 1: Voltage Gradient Test Locations and Test Apparatus**

Table 3 provides data collected during both the March 2022 and March 2023 cell-to-cell survey with locations of the testing included on Figure 1. The data shows only slight voltage gradients throughout the testing area, generally less than 15 millivolts in March 2022 and generally 1 – 2 millivolts during the March 2023 testing. Concern would be raised had the voltage gradients been on the order of 100 or more millivolts. During the March 2022 testing, a vessel was moored at the south side of the East Breakwater. There were no large vessels moored adjacent to the North Breakwater. During the 2023 survey there were vessels moored at both the south side of the East Breakwater (not connected to shore power) and adjacent to the North Breakwater (the vessel was plugged into shore power).

Note: Readings 5, 6, 7, 10, and 14 are adjacent to transformers.
