**Sample Inspection & Assessment
of Steel Batter Piles
East Breakwater
Fidalgo Marina
Anacortes, WA**

September 2024
24-2669

**RE: Sample Inspection & Assessment of Steel Batter Piles
East Breakwater, Fidalgo Marina, Anacortes, Washington**

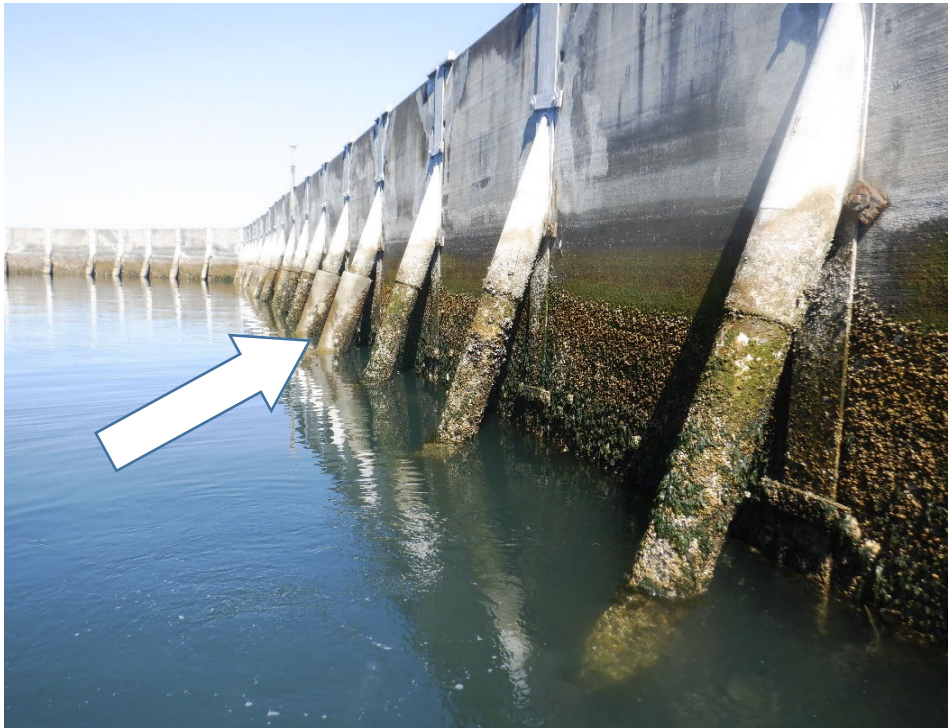
PHOTO No. 1:

East Breakwater, Looking North - This investigation focused on inspection of the batter piles which were not included in the recent concrete encasement and anode installation contract. Note the piles which have been encased in concrete from the intertidal zone to the mudline (refer to arrow).

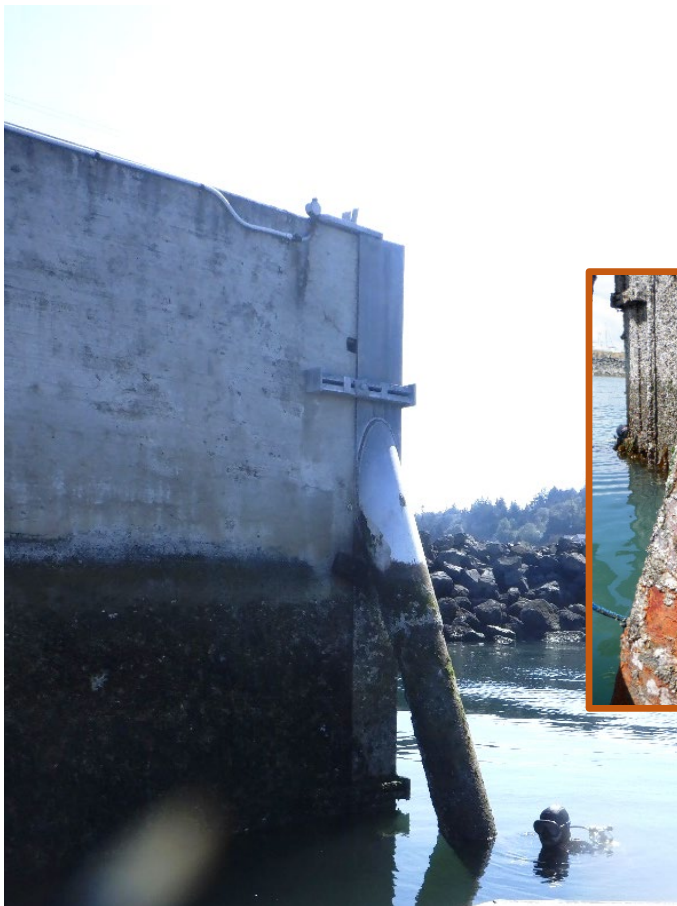
PHOTO No. 2:

Batter Pile No. 79 - Note the overall good condition of the batter pile in 2024 and the lack of any visible active orange surface corrosion in the intertidal zone.

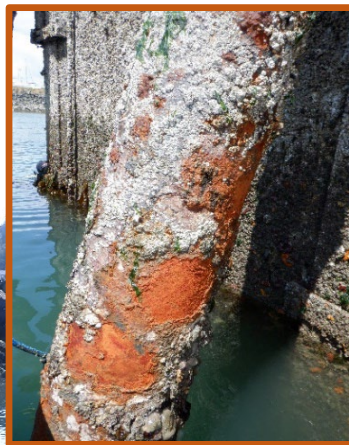
The small insert photo, taken in 2021, shows areas of bright active orange corrosion indicative of on-going section loss. As indicated above, no active orange corrosion was found on any of the piles included within this sample inspection.

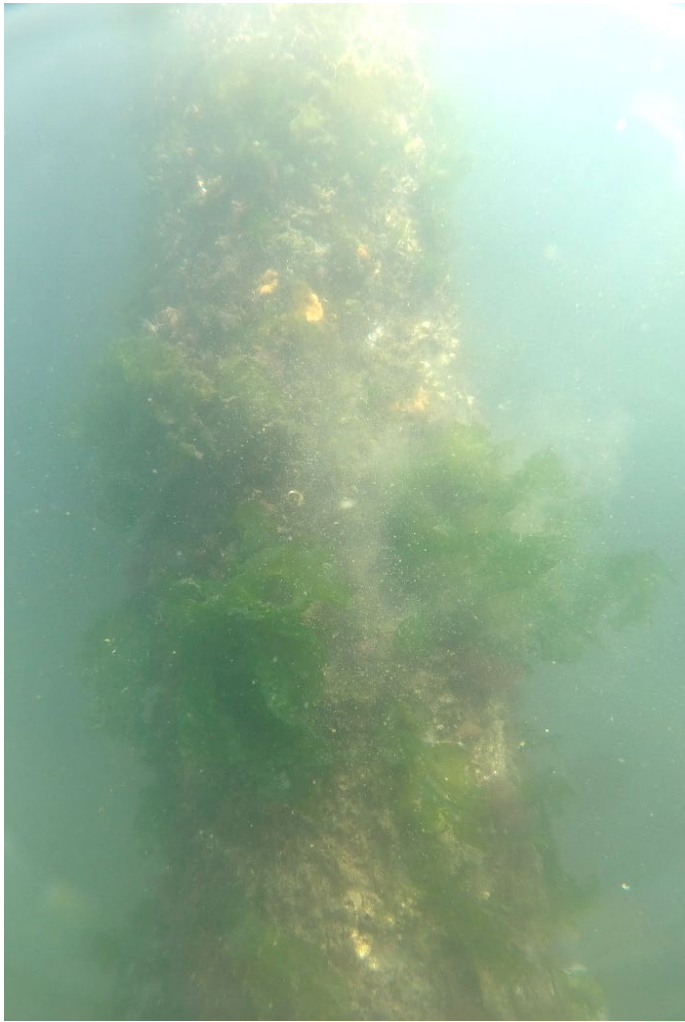
PHOTO No. 3: Batter Pile No. 27 - Note the moderate marine growth on the pile in the lower intertidal zone. Also note the lack of bright orange surface corrosion which was evident on the pile during the previous 2021 inspection.

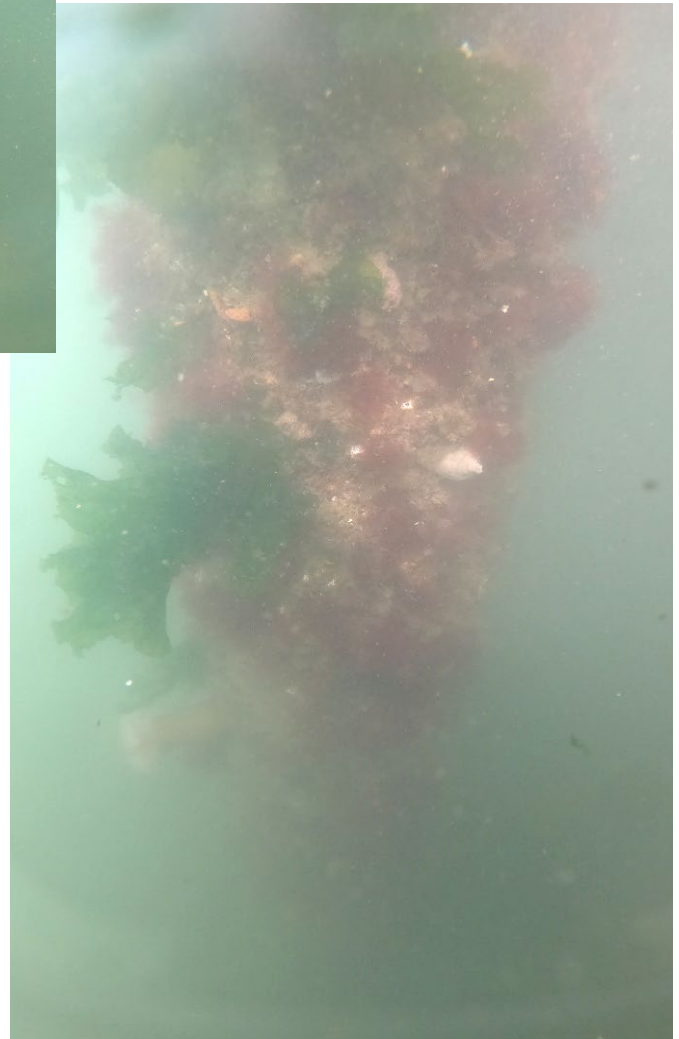
PHOTO No. 4: Batter Pile No. 27 - Inspection of the piles in the submerged and mudline zones, also found no indication of bright orange surface corrosion that is indicative of on-going section loss.

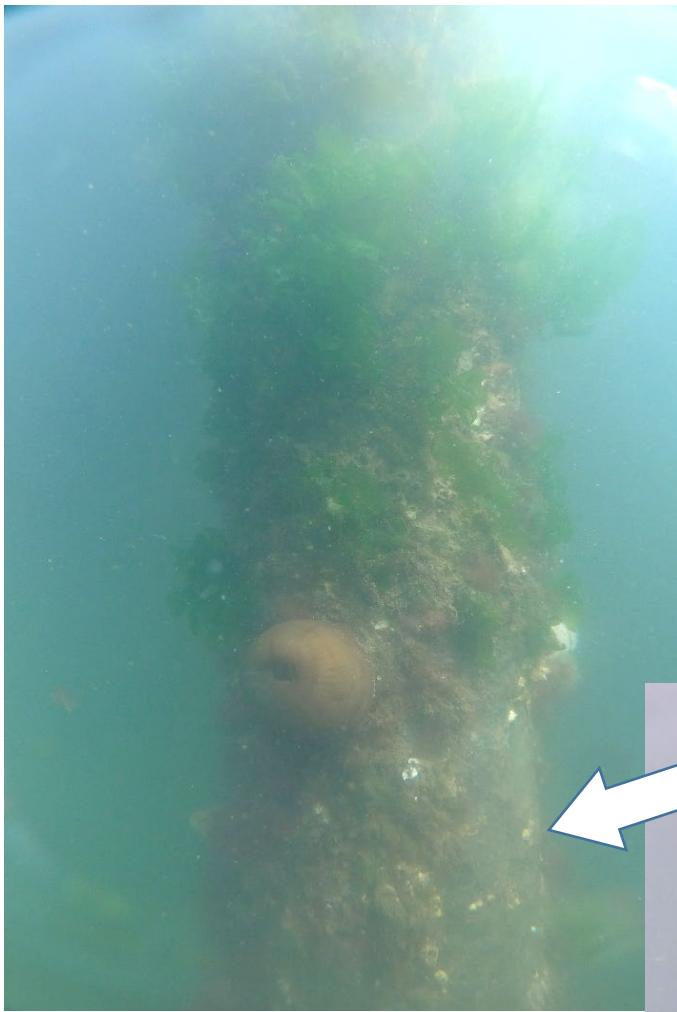
Pile Number	2024 Readings		2021 Readings		Combined Average Loss (%)
	Average Thickness (inches)	Average Percent Loss (%)	Average Thickness (inches)	Average Percent Loss (%)	
9 Br	0.318	15.3%	0.295	21.3%	18.3%
20 Br	0.290	22.7%	0.321	14.3%	18.5%
38 Br	0.315	16.0%	0.293	22.0%	19.0%
45 Br	0.290	22.7%	0.300	20.0%	21.3%
56 Br	0.289	23.0%	0.345	8.0%	15.5%
65 Br	0.306	18.3%	0.353	6.0%	12.2%
79 Br	0.343	8.7%	0.283	24.7%	16.7%

PHOTO No. 5: Batter Pile No. 38 - Note the generally good condition of the pile in areas which are not covered by marine growth (refer to arrow). Also note the lack of active orange surface corrosion on the pile.

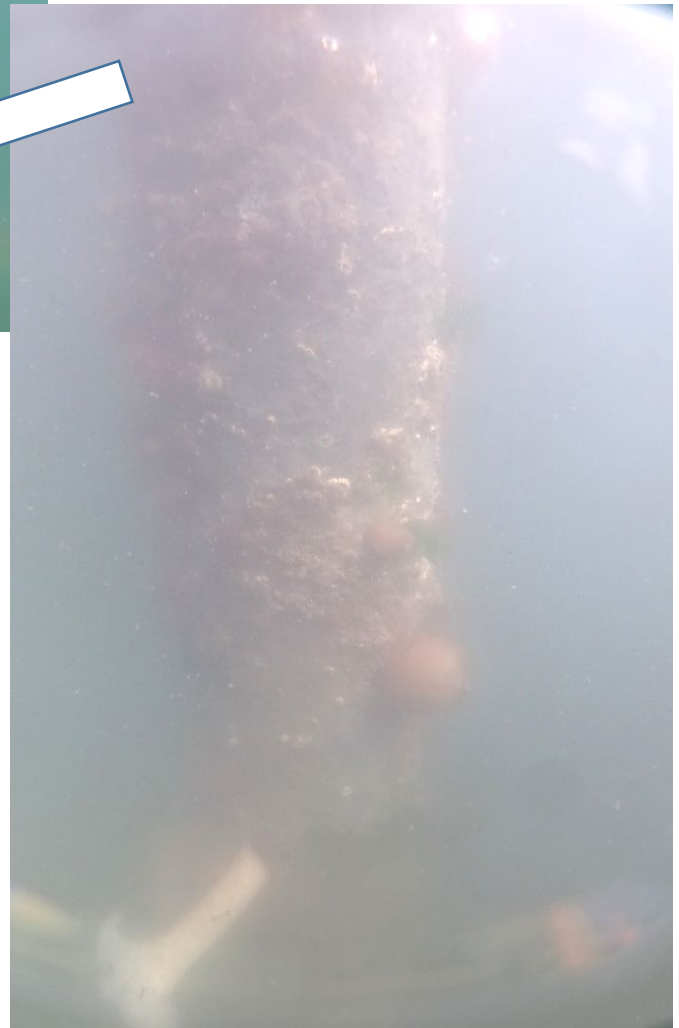
The CP values as determined relative to a CuCuSO₄ reference cell were all found to be above the -0.850 V threshold that indicates cathodic protection of steel in seawater. The CP values were found to range from -0.984 to -1.060 V which indicate that the steel is being protected by the sacrificial anode system.

PHOTO No. 6: Batter Pile No. 38 - Visual investigation of the piles along with the data obtained from the Corrosion Potential survey, found the batter piles to be protected from on-going corrosion. These conditions were typical of the inspected piles with no evidence of active surface corrosion noted.

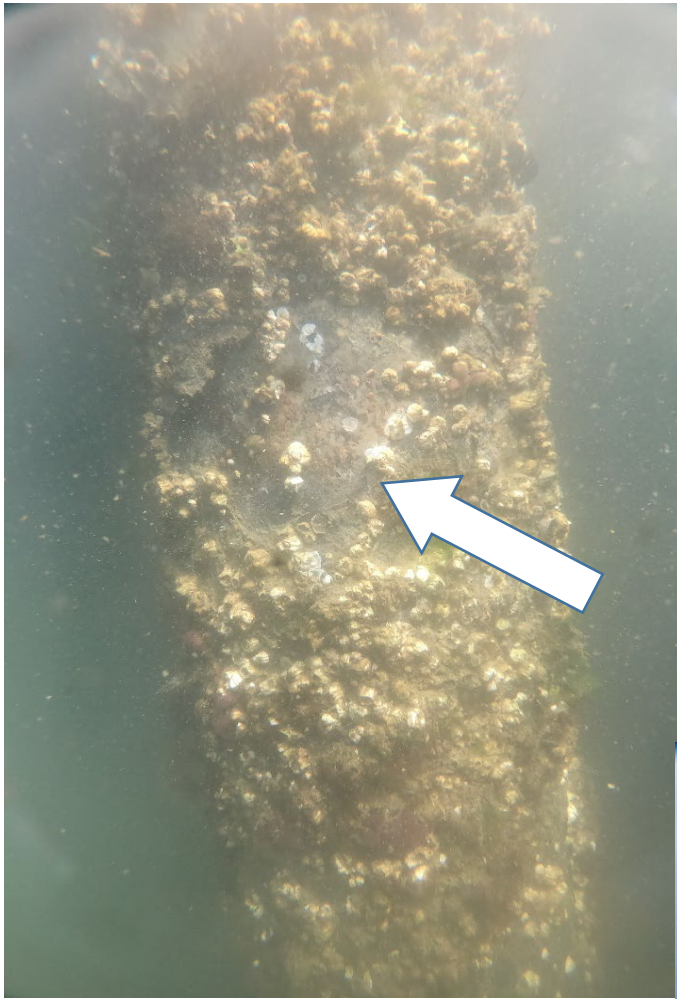
PHOTO No. 7: Batter Pile No. 56 - Note the general good condition of the steel on this pile in the intertidal zone (refer to arrow).

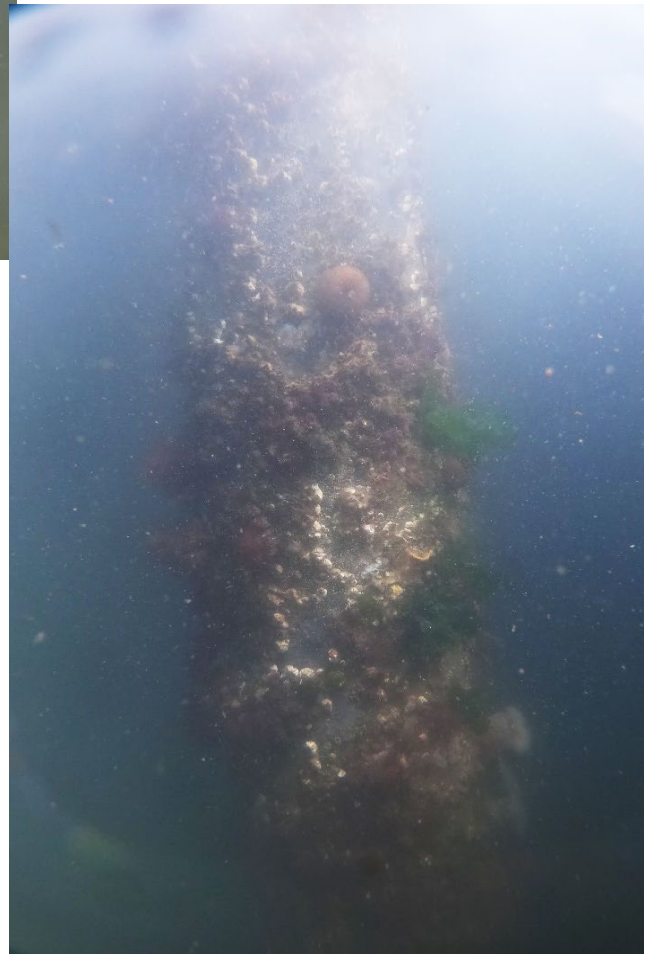
PHOTO No. 8: Batter Pile No. 56 - Inspection of the pile in the submerged zone also did not identify any active on-going corrosion of the steel.

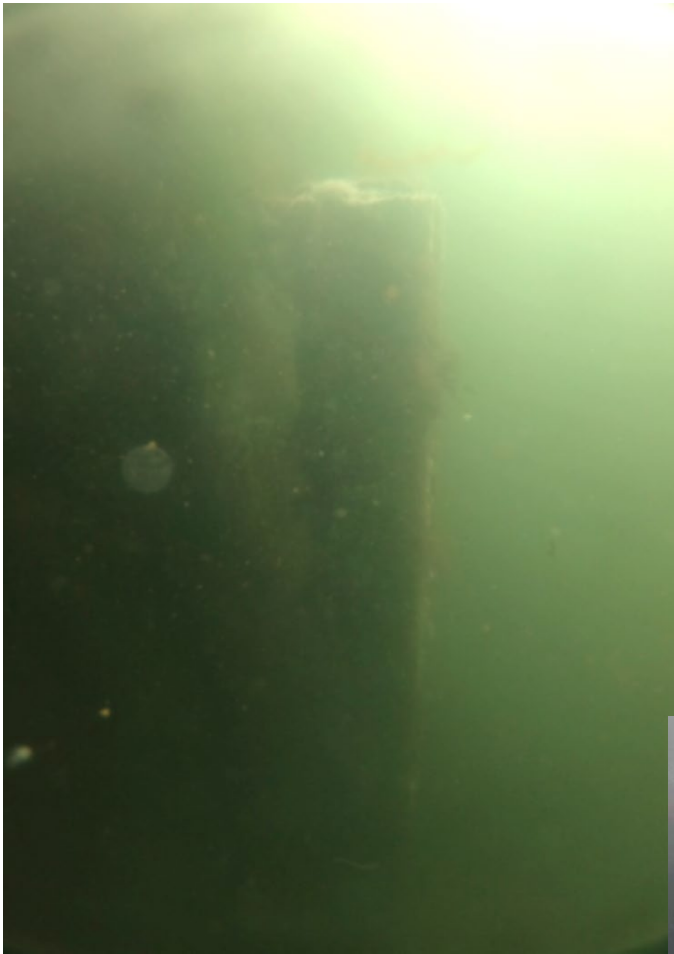
PHOTO No. 9: Vertical Pile No. 27, Anode
- Cursory observation of the anodes which have been installed on the vertical piles throughout the breakwater found them to be in good condition with an estimated 95-99% of their volume remaining.

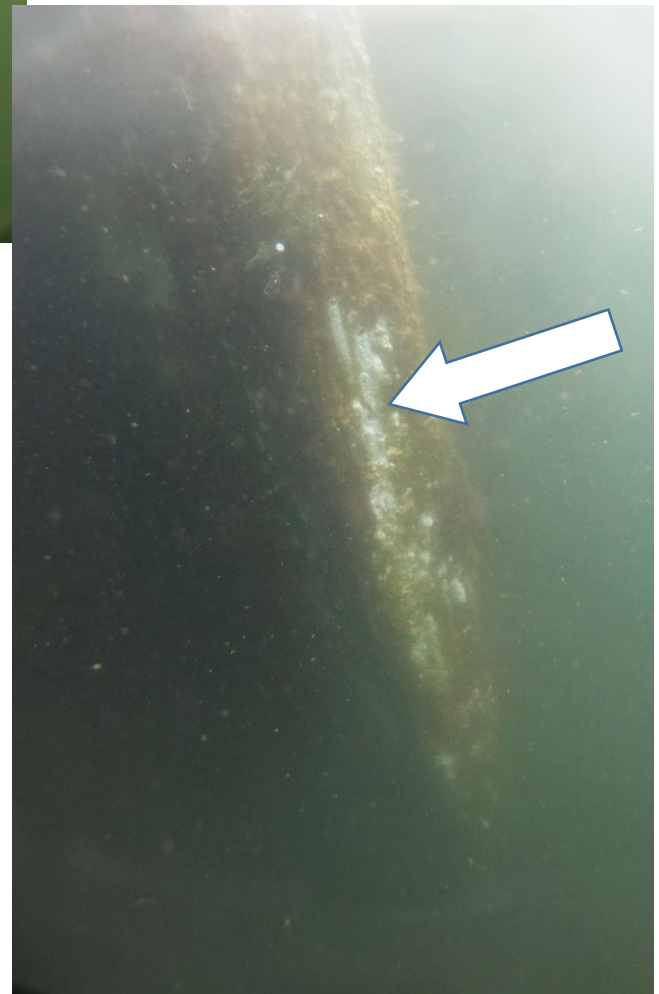
PHOTO No. 10: Vertical Pile No. 27, Anode
Close-up - Close investigation of several anodes found them to be functioning, as evidenced by areas that are clean of marine growth (refer to arrow).
