W E T H E R H O L T A N D A S S O C I A T E S , I N C .

**FIDALGO MARINA
ROOF EVALUATION
SEPTEMBER 6TH, 2024**

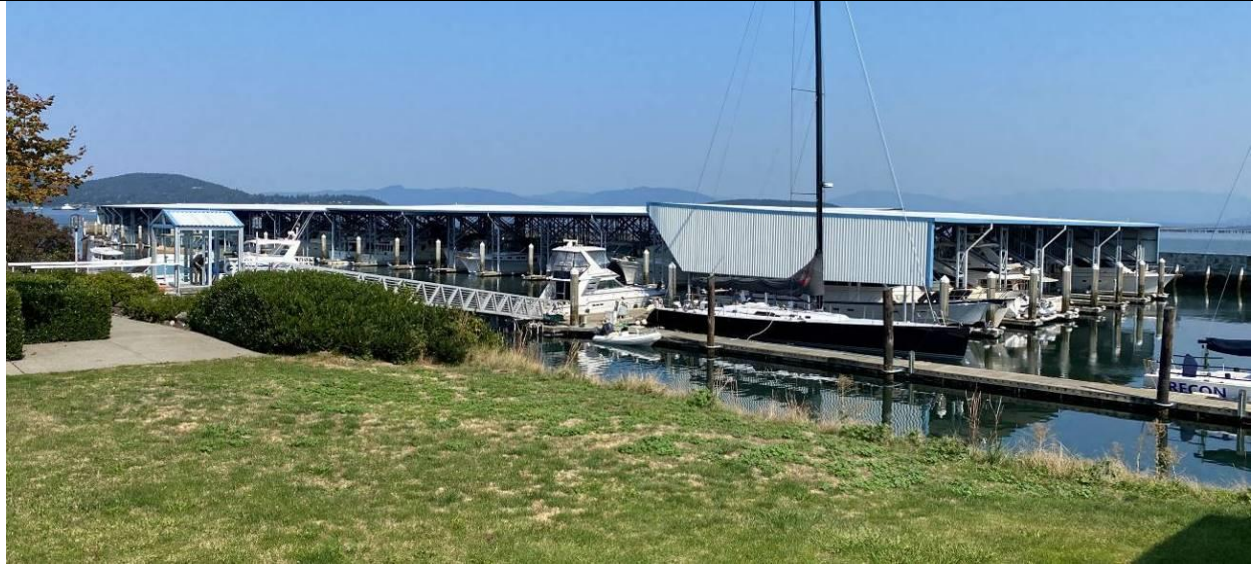
Photograph 1: Overview of the project building, as viewed from the southwest.

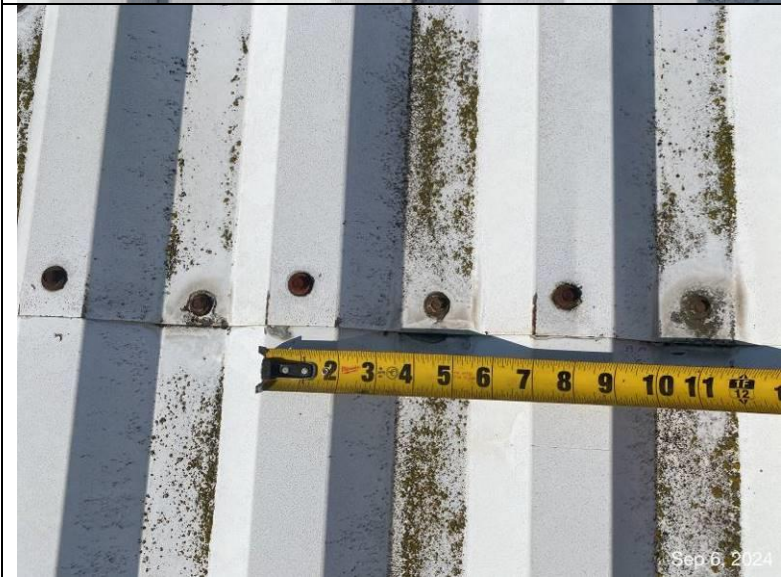
Photograph 12: Fastener spacing at the overlaps of the roof panels measuring at approximately 4-inches on-center.

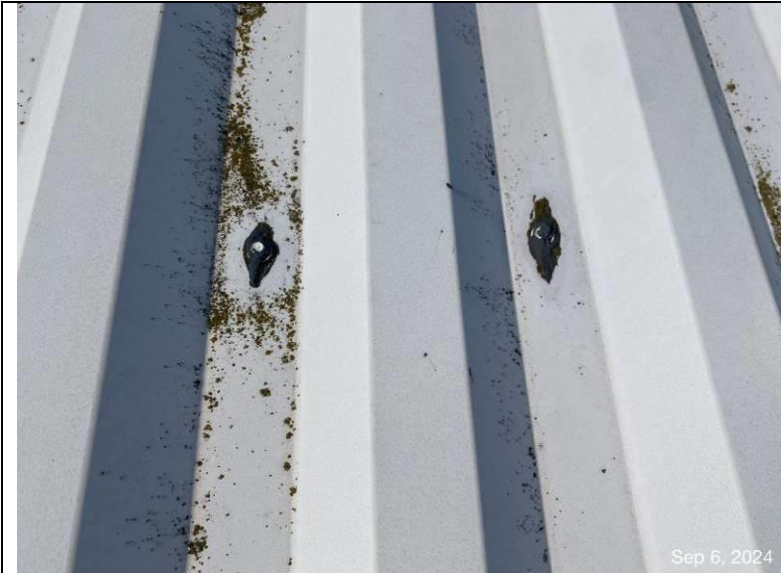
Photograph 13: Fasteners in the field of the roof sealed with sealant.

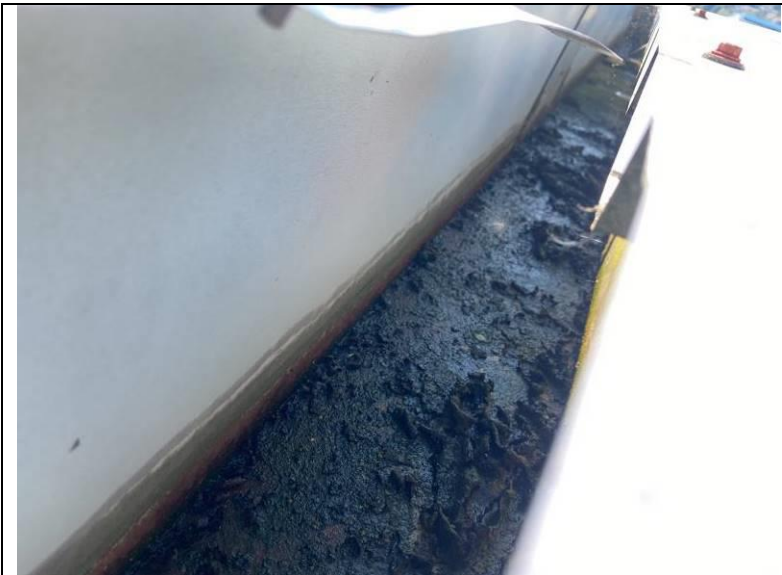
Photograph 16: View of the inside of the gutter, including debris and corrosion along the bottom surface.

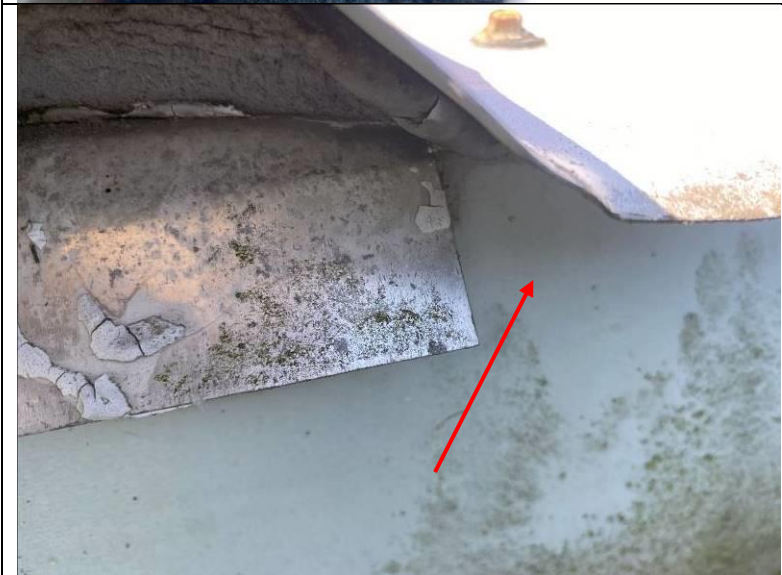
Photograph 17: View of the gutter flange under the metal roof panels. Note the flashing at the eave of the roof extending into the gutter missing at some locations.

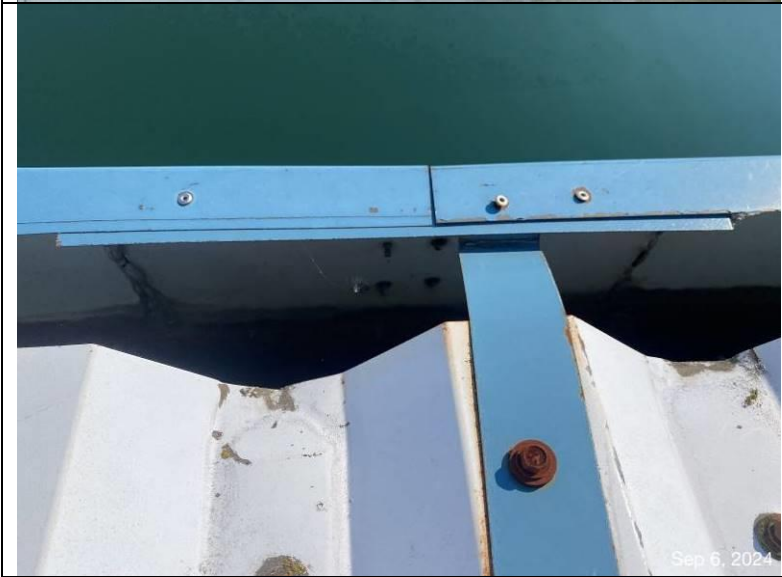
Photograph 18: View of gutter laps with flat plate on the inside of the gutter, embedded in sealant and secured with rivets.

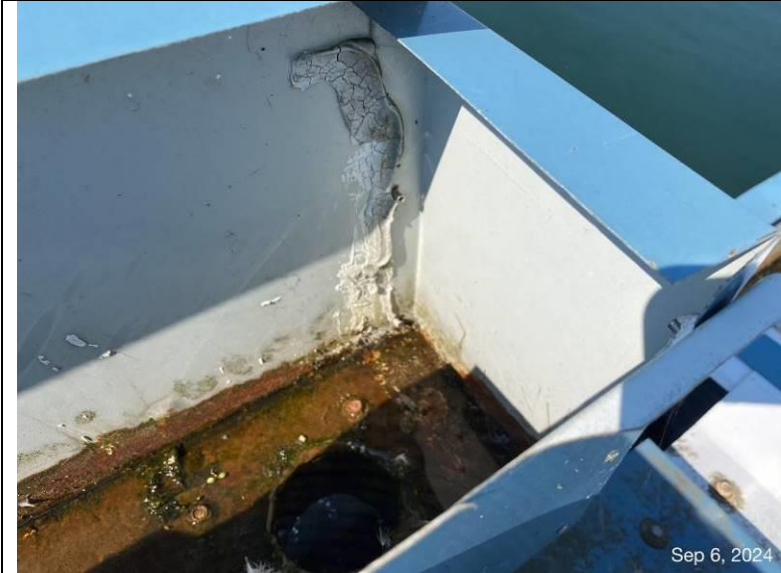
Photograph 20: View of the end of the gutter with the closure plate sealed with sealant.

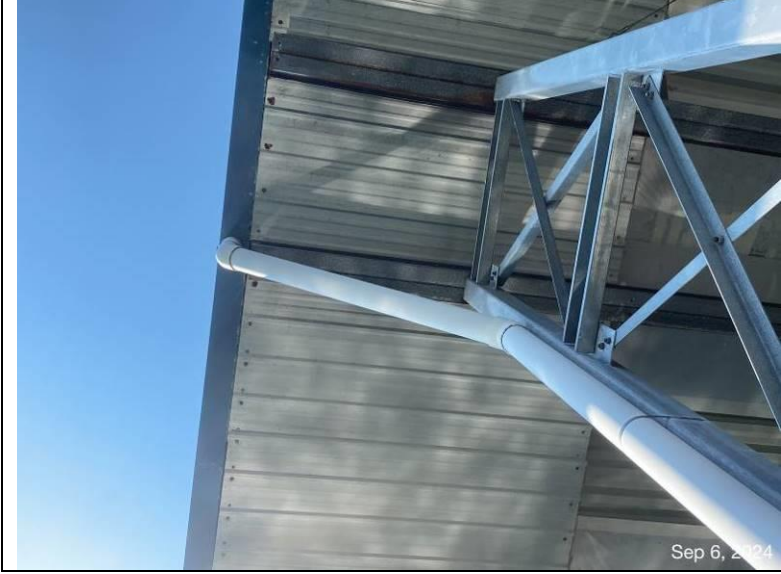
Photograph 21: View of the downspout and prefinished metal soffit panels.

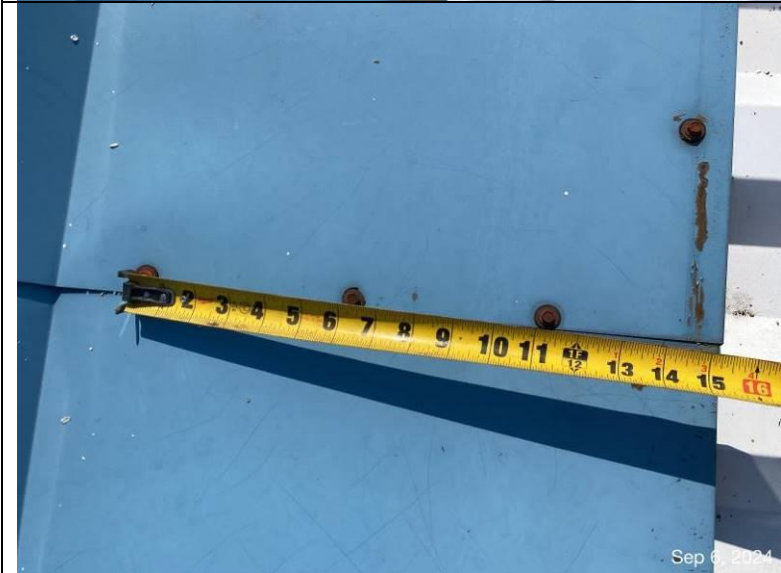
Photograph 26: View of the ridge flashing secured directly through the laps at approximately 6-inches on-center, not allow for expansion/contraction. Note corrosion of fasteners.

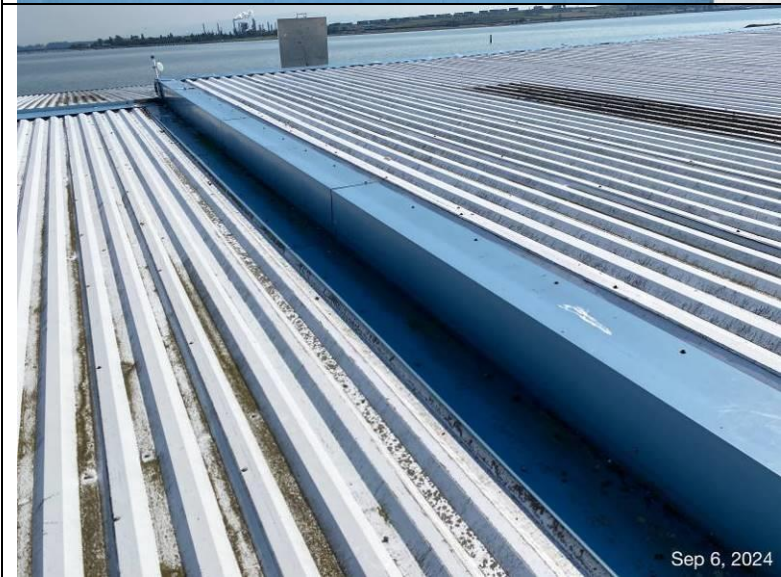
Photograph 27: View of transition flashings at the roof plane changes.

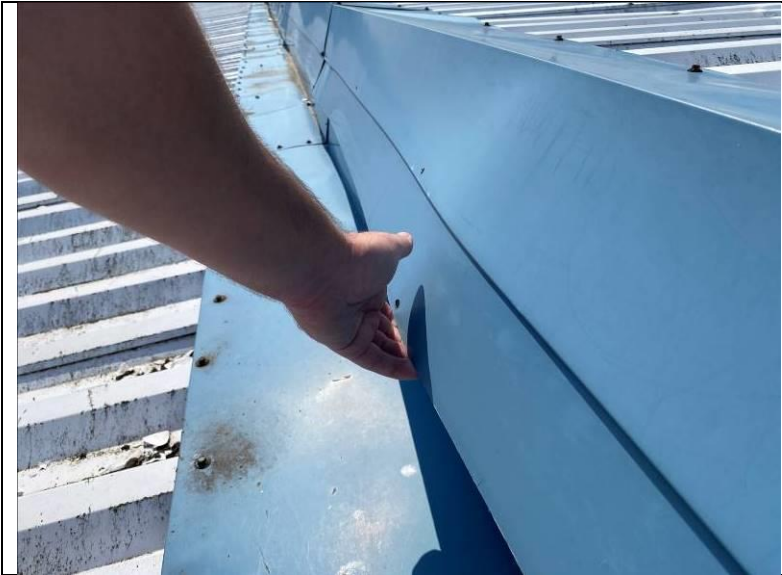
Photograph 31: View of missing fasteners at the rake to roof-to-wall overlap.

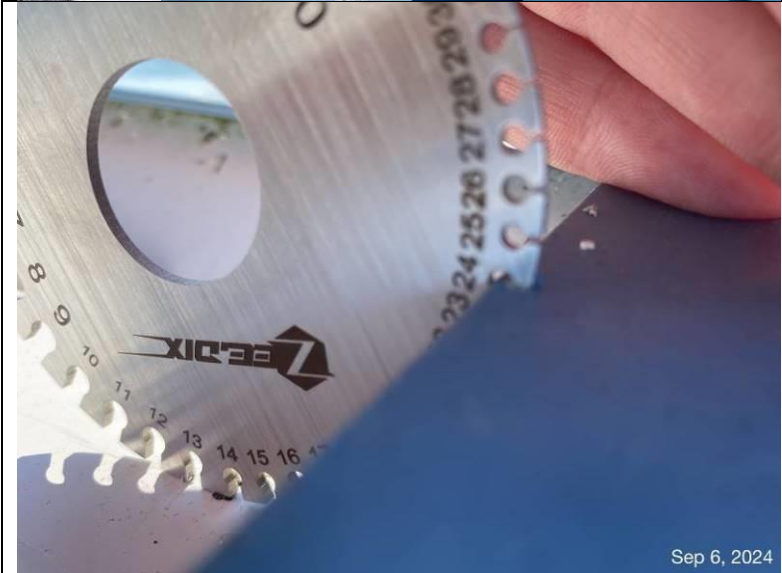
Photograph 32: View of sheet metal flashing with a metal gauge inserted at the end of the flashing measuring at 24-gauge.

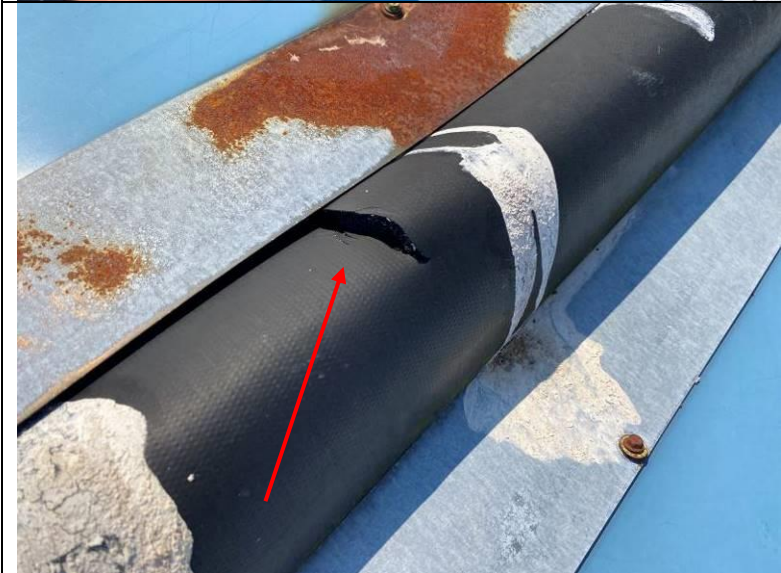
Photograph 38: View of damage in the expansion joint membrane.

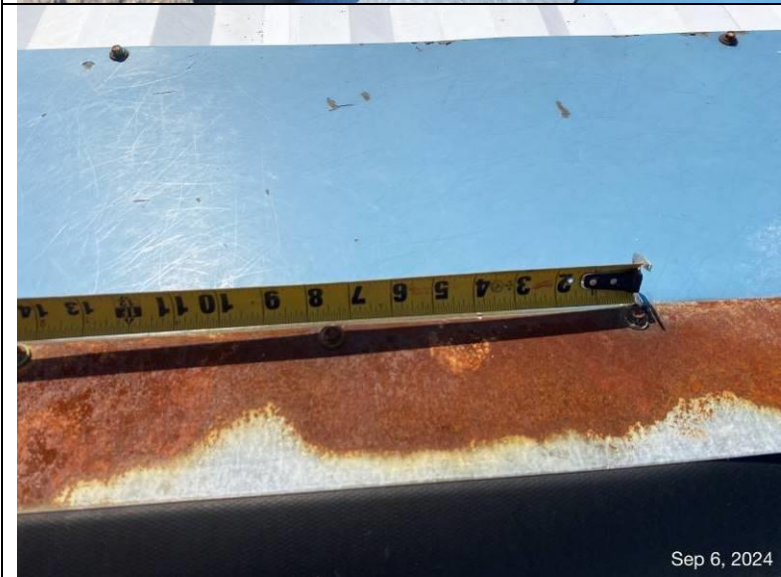
Photograph 39: Expansion joints flanges secured to the sheet metal flashings at approximately 8-inches on-center.

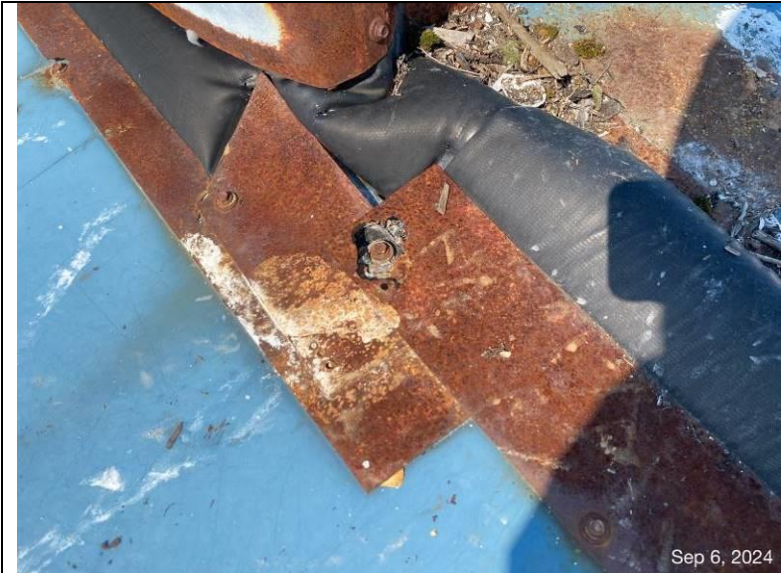
Photograph 40: View of corroded expansion joint flanges.

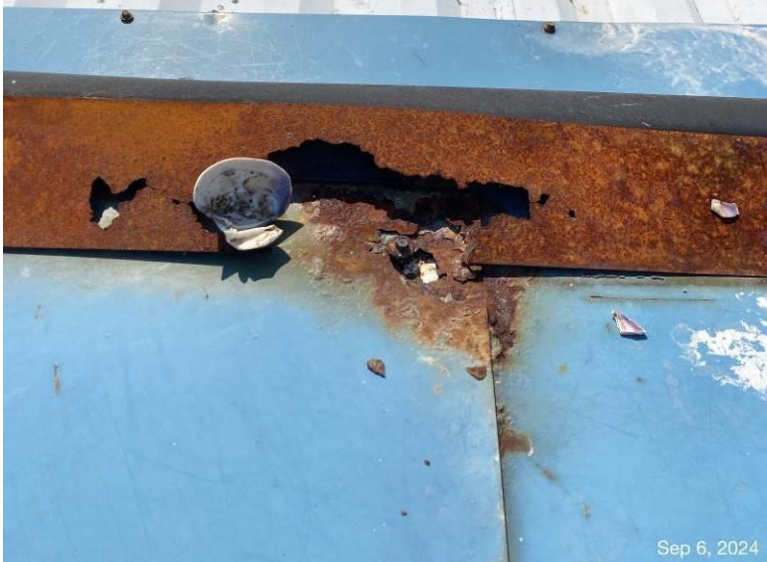
Photograph 41: Alternative view of corroded expansion joint flanges.

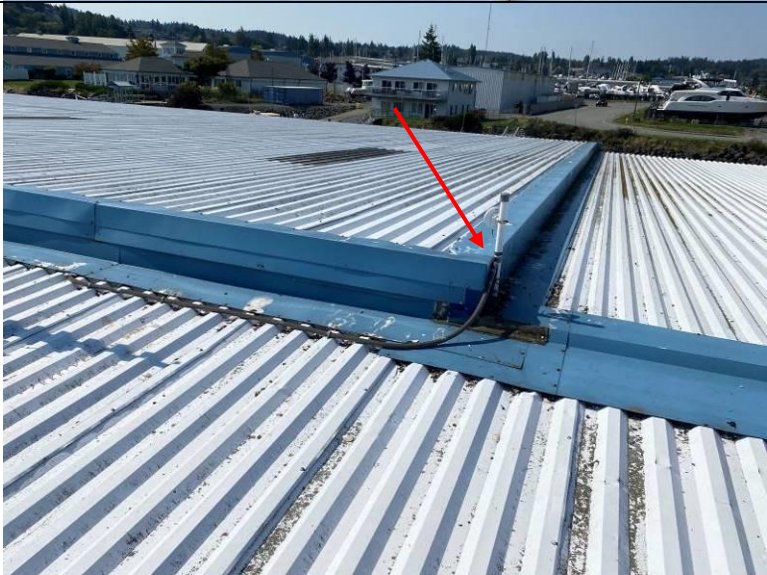
Photograph 42: View of an antenna penetration at the roof plane change, secured through the roof-to-wall transition flashing.

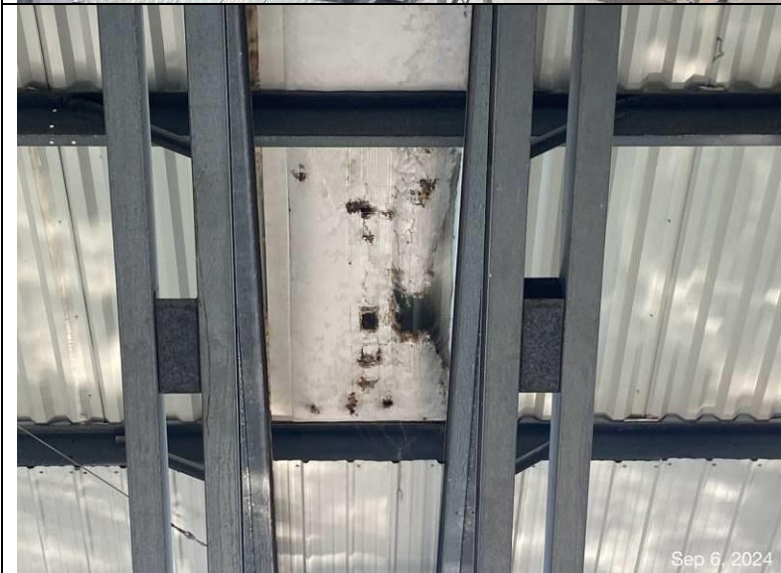
Photograph 47: View of damaged condensation blanket.

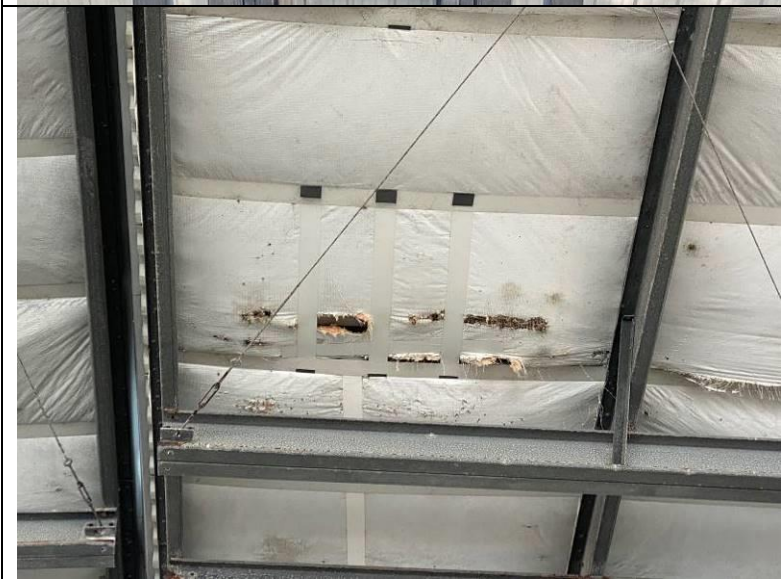
Photograph 48: Alternative view of damaged condensation blanket.

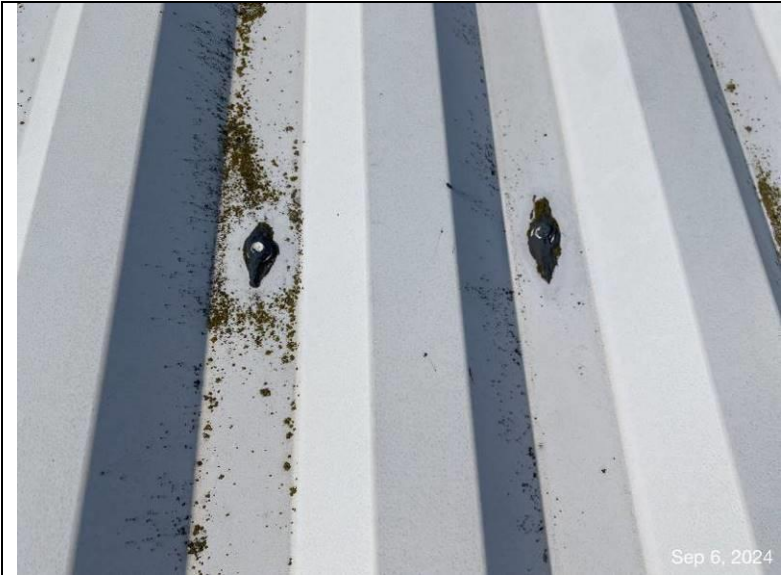
Photograph 49: View of the fasteners in the field of the roof sealed with sealant.

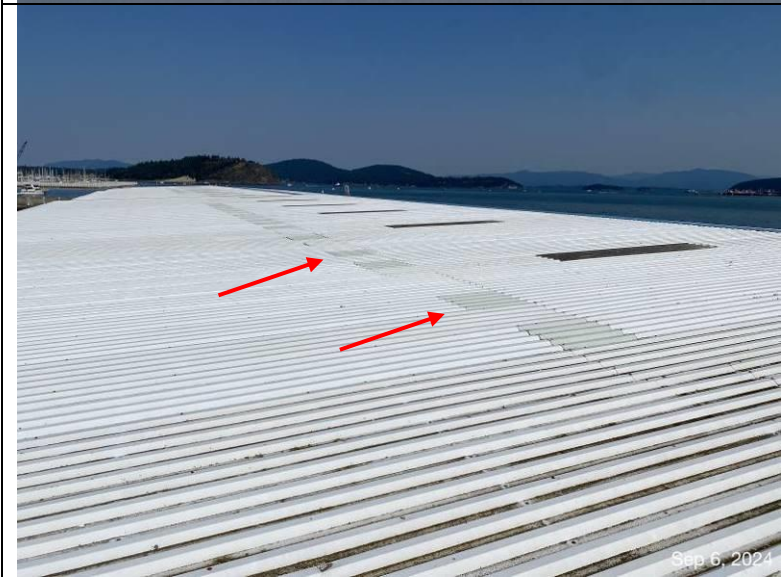
Photograph 51: View of the roof with supplemental roof panels, reportedly installed when several panels stored on the roof blew off during 1996 roof replacement. Note the color difference.

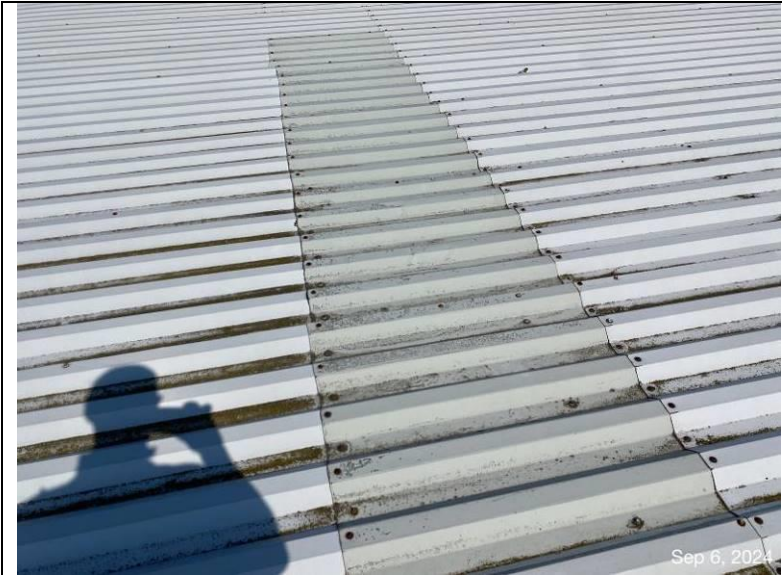
Photograph 52: Alternative view of supplemental roof panels.

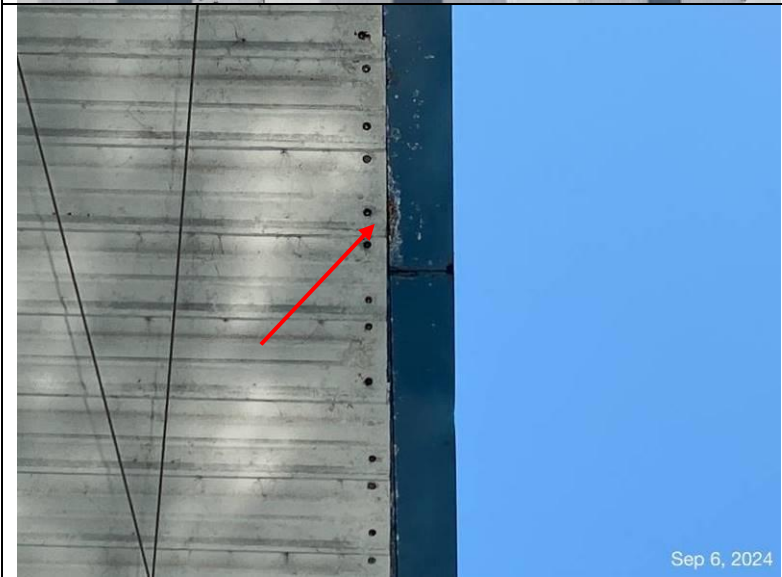
Photograph 54: View of roof panel eave edge corroded at the fastener penetrations, as well as corroded gutter edges.

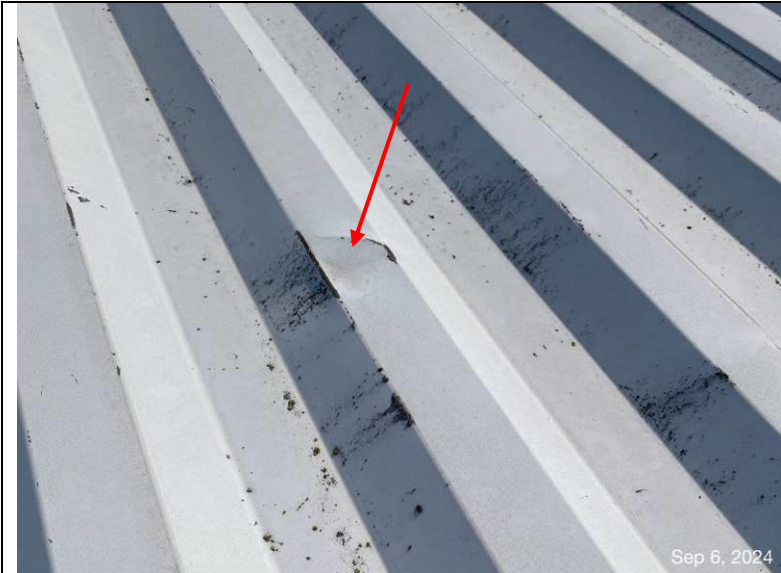
Photograph 55: View of damaged roof panels with slight corrosion.

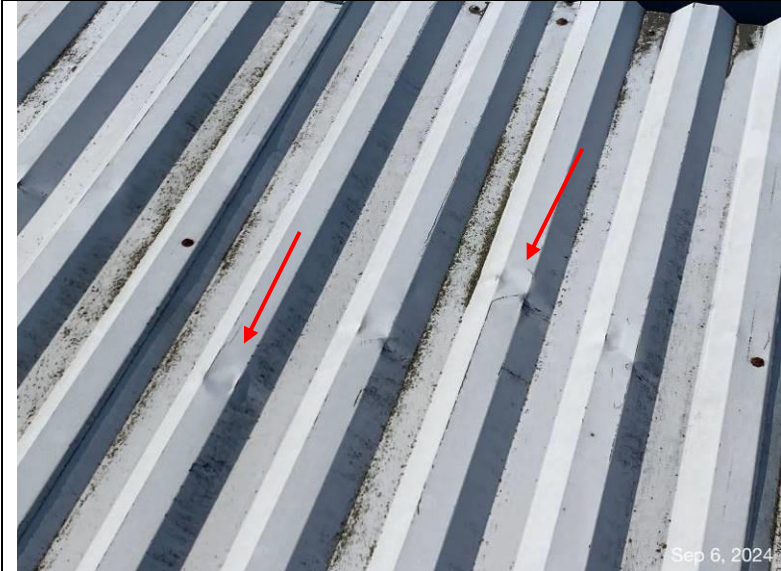
Photograph 56: View of damaged roof panels with slight corrosion.

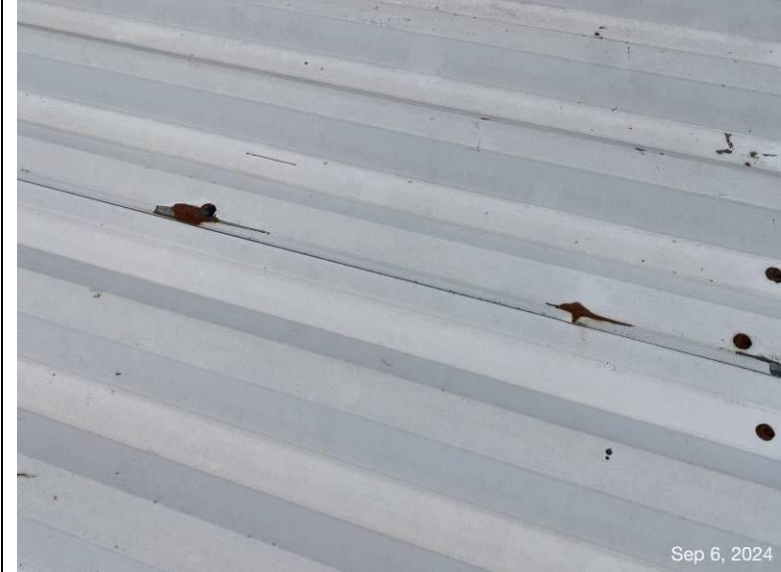
Photograph 57: View of damaged roof panels with slight corrosion.

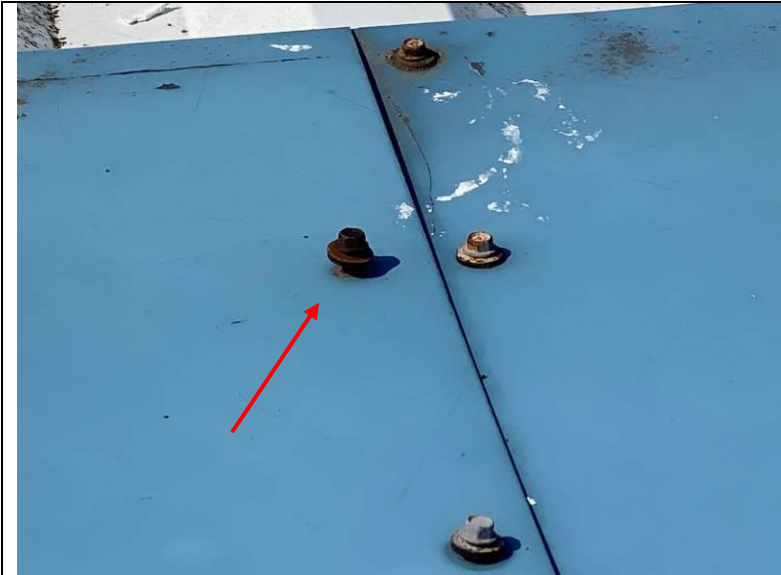
Photograph 58: View of fasteners backing out at the ridge of the roof.

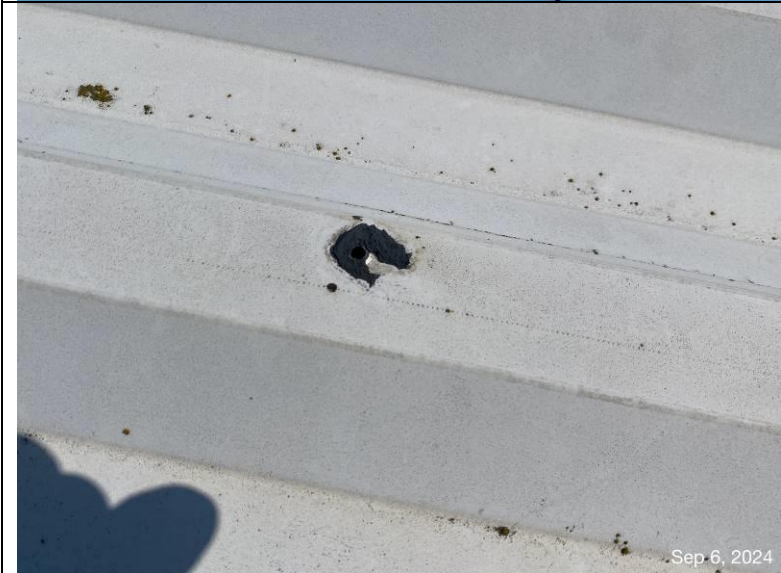
Photograph 59: View of missing fastener in the field of the roof panel.

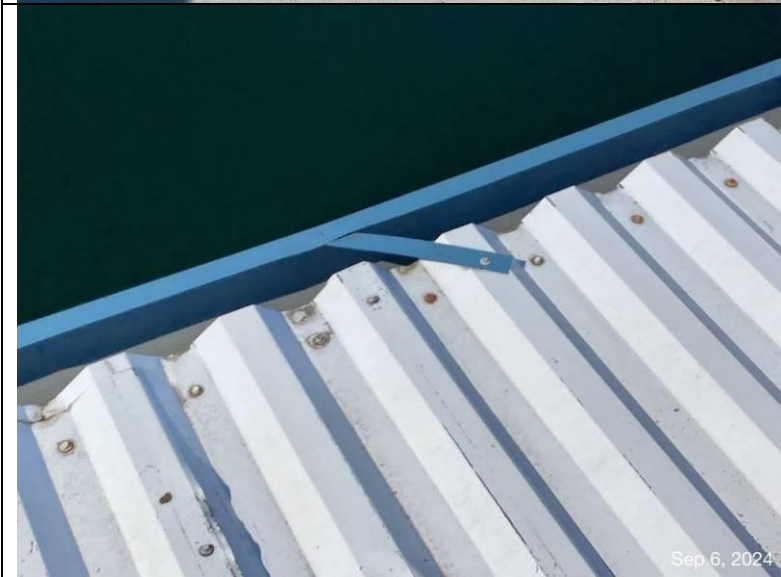
Photograph 60: View of loose gutter straps with missing fasteners.

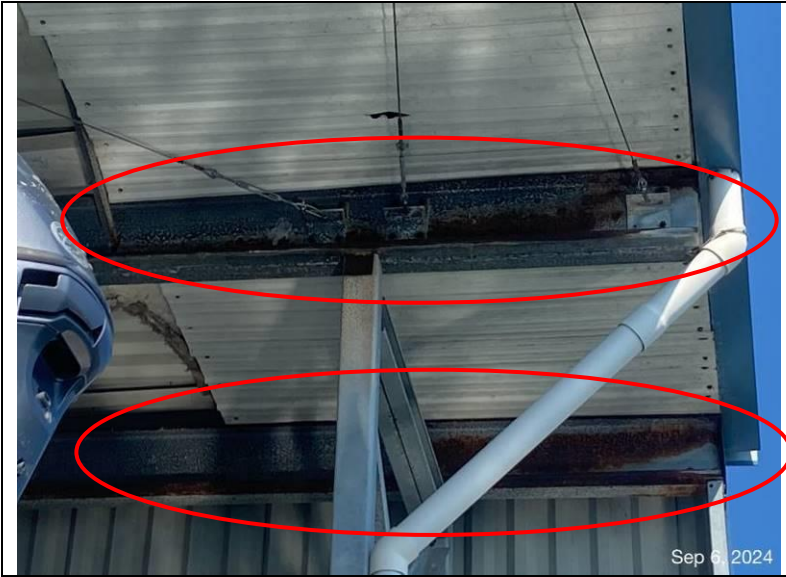
Photograph 61: View of surface corroded steel beams.

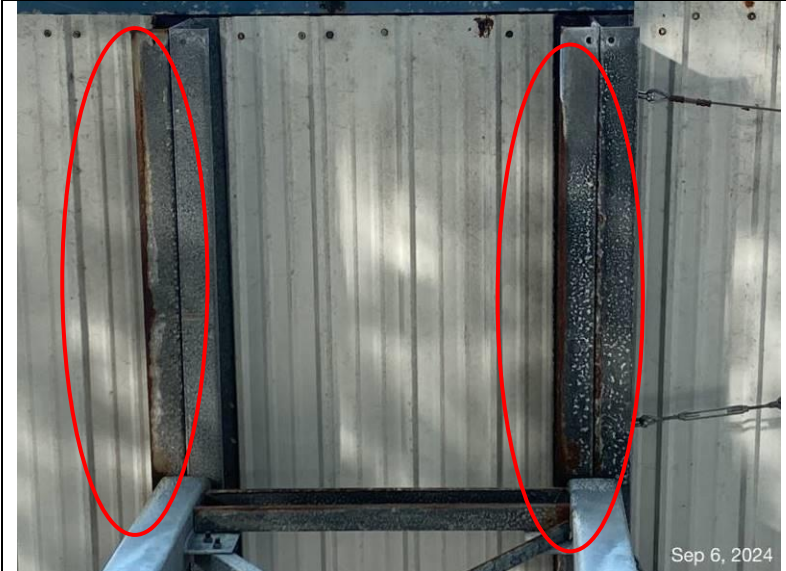
Photograph 62: Alternative view of corroded steel beams.

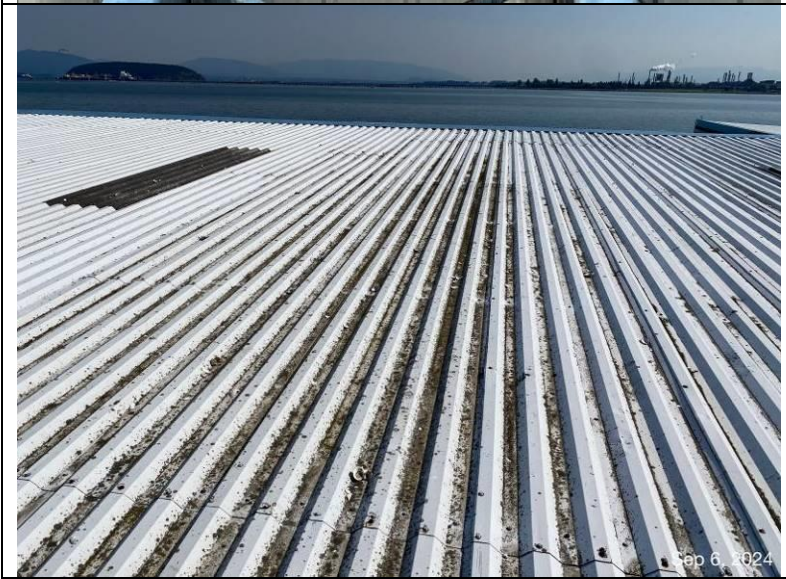
Photograph 63: View of lichen and organic growth on the surface of the roof panels.
