**Underwater Inspection &
Assessment of Piles & Floats
Fidalgo Marina
Anacortes, WA**

June 2021
21-2604

**RE: Underwater Inspection & Assessment of Piles & Floats
Fidalgo Marina, Anacortes, Washington**

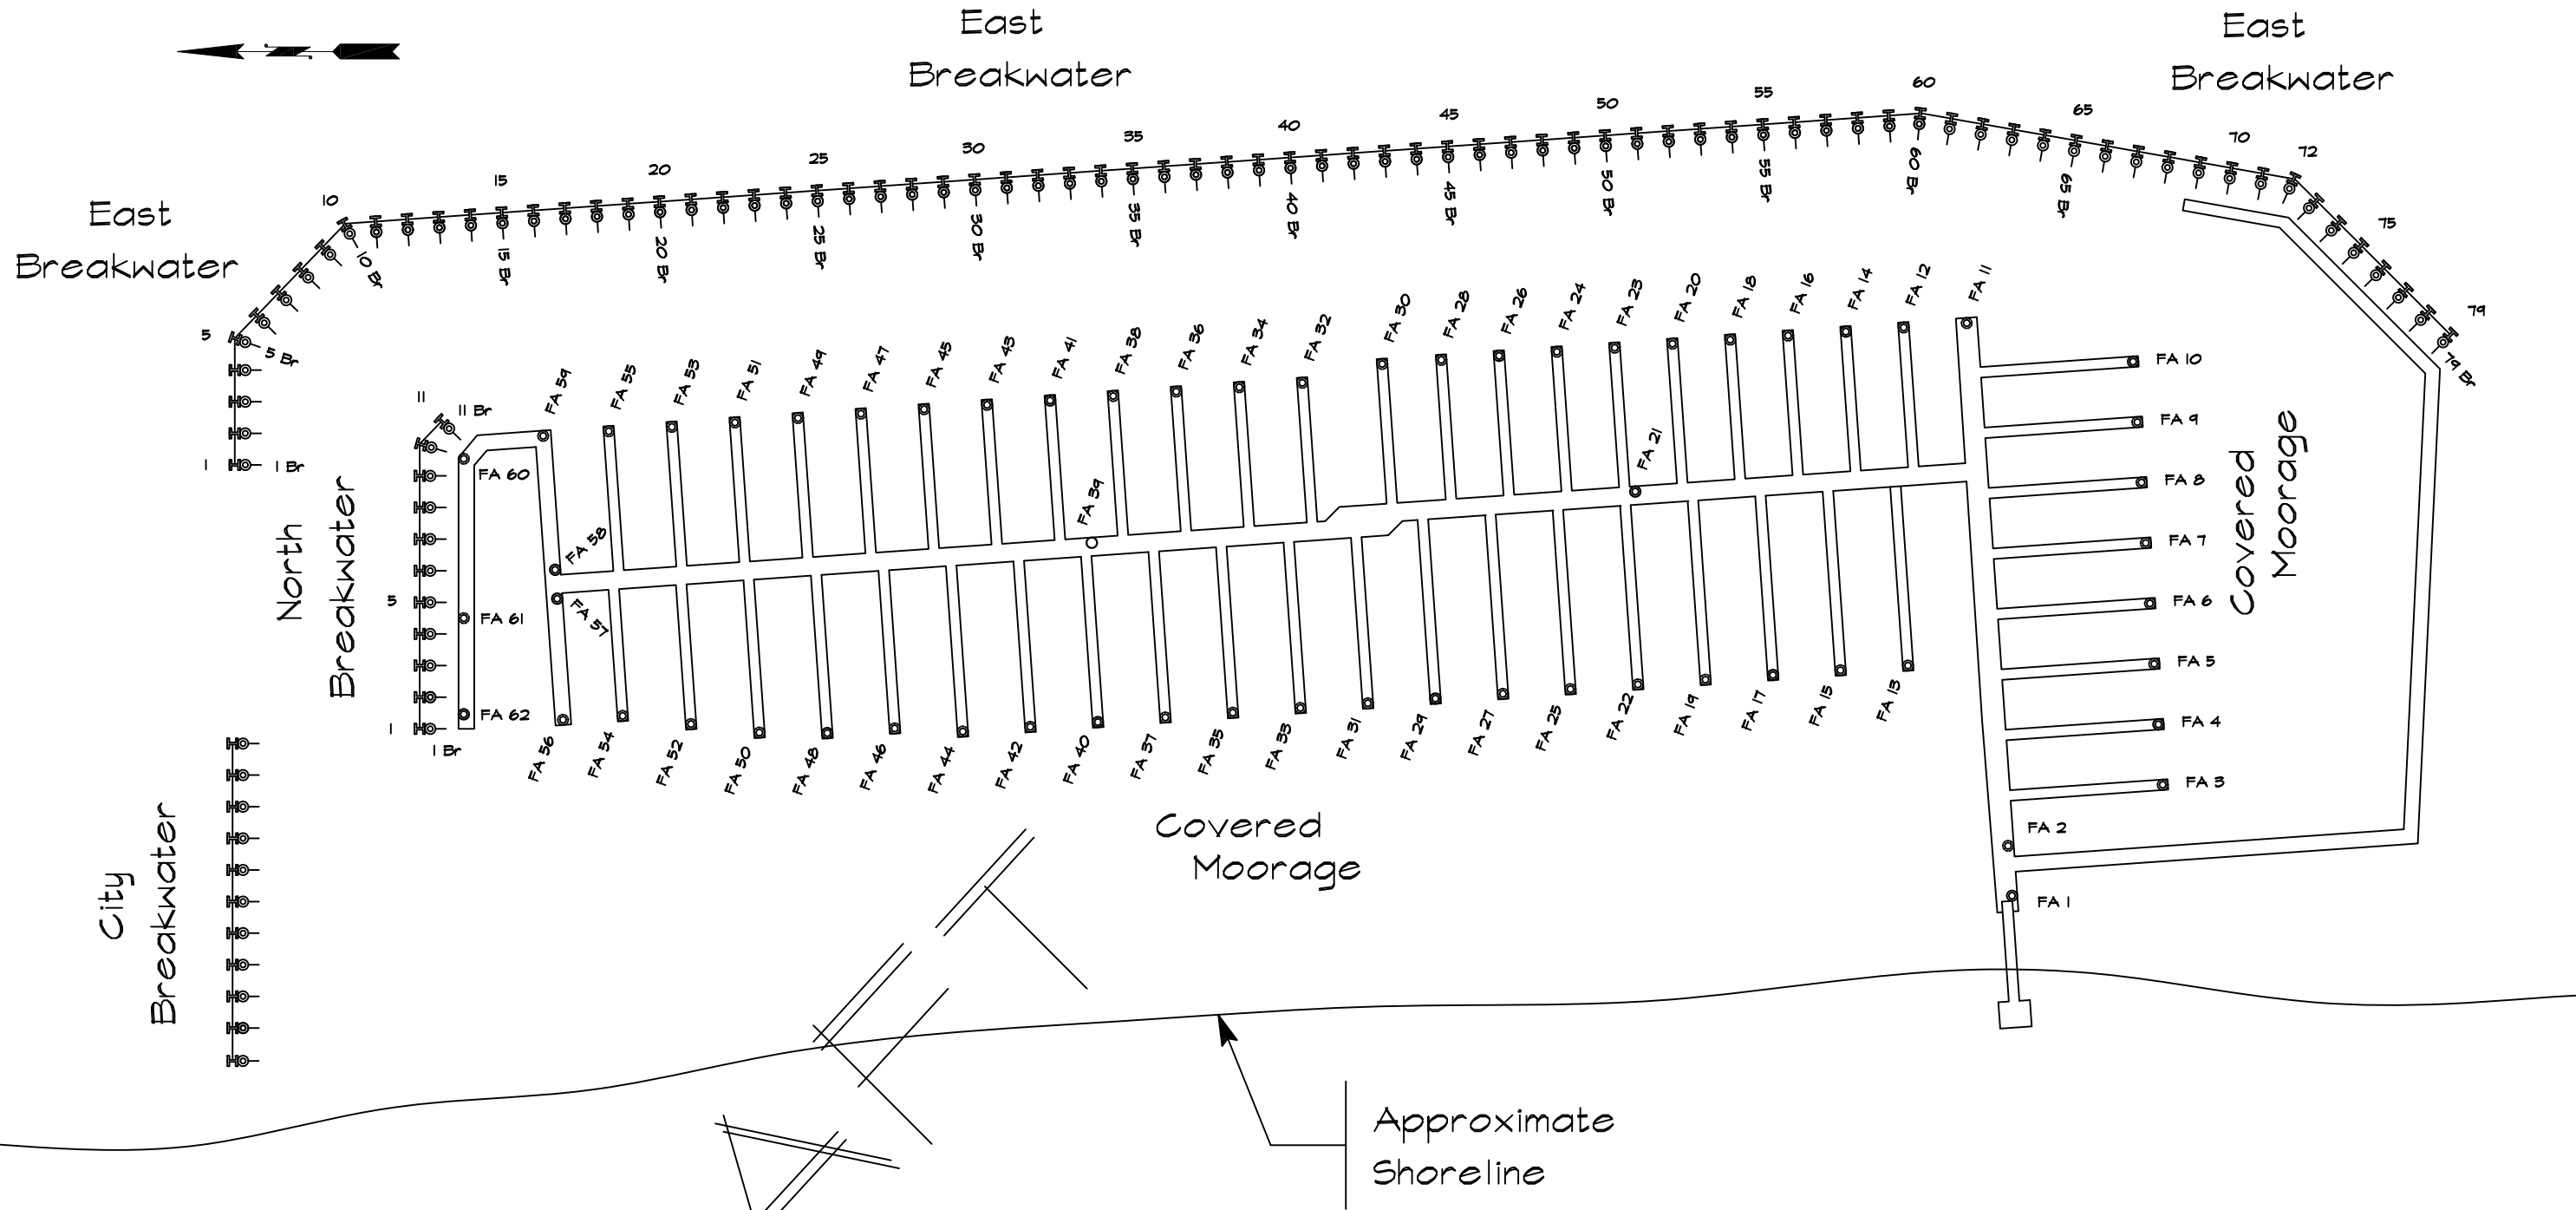
Level III ultrasonic thickness readings taken on a representative pipe pile in the breakwater were found to range from 0.130 inches to 0.200 inches with an average thickness of 0.165 inches (~56.0% loss). The most significant measured loss was obtained in the intertidal zone on Pile No. 2 Br, resulting in ~65.3% loss. It should be noted that this pile has ultimately failed with >60% of the section lost in the submerged zone. Refer to Photo No. 22.

PHOTO No. 22: North Breakwater, Pipe
Pile No. 2 Br - Inspection
found extensive
corrosion, perforation and
loss of section on this
batter pile. Note the blue
line indicating the location
of the original pipe pile
wall which is now
missing. Inspection
found nine of the eleven
batter piles in the North
Breakwater and ten of the
79 batter piles in the East
Breakwater to have
sustained corrosion to the
point of perforation.
